# **FINAL REPORT**

**SERIOUS INCIDENT**  
**Aircraft B787-8 registration marks LN-LND,**  
**Rome Fiumicino International Airport, Italy,**  
**10<sup>th</sup> of August 2019**

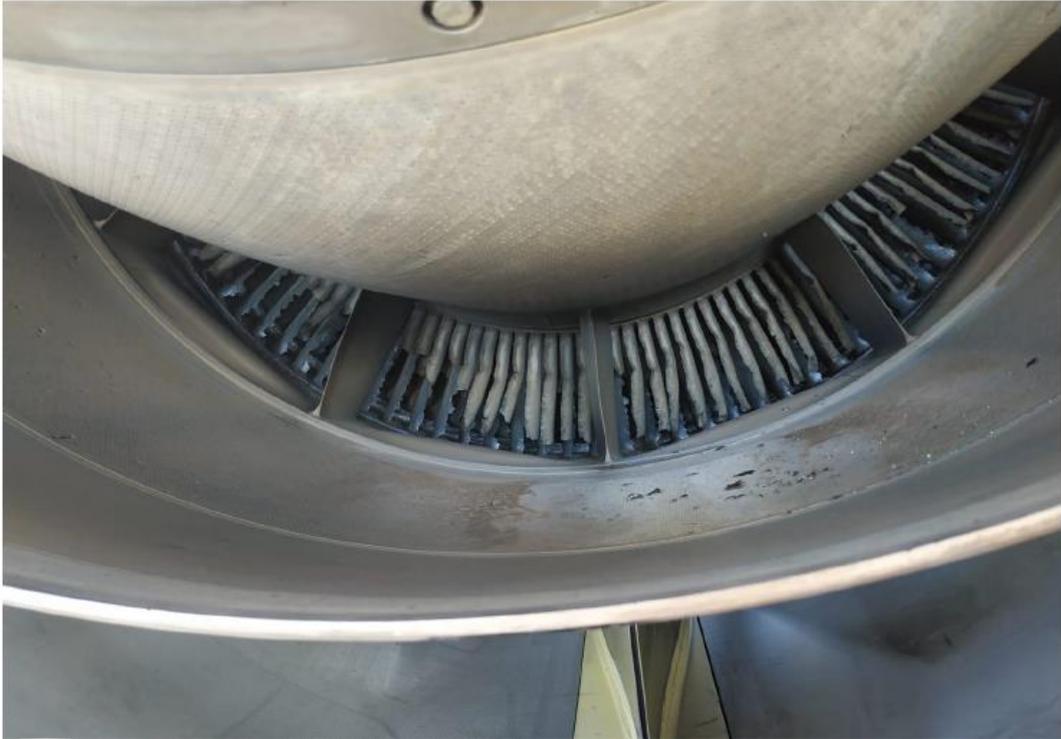
Numerous fragments were found in the exhaust cone. Left engine last stage turbine damage was visible from the outside (photo 2).

Photo 2: left engine damage as visible from the outside.

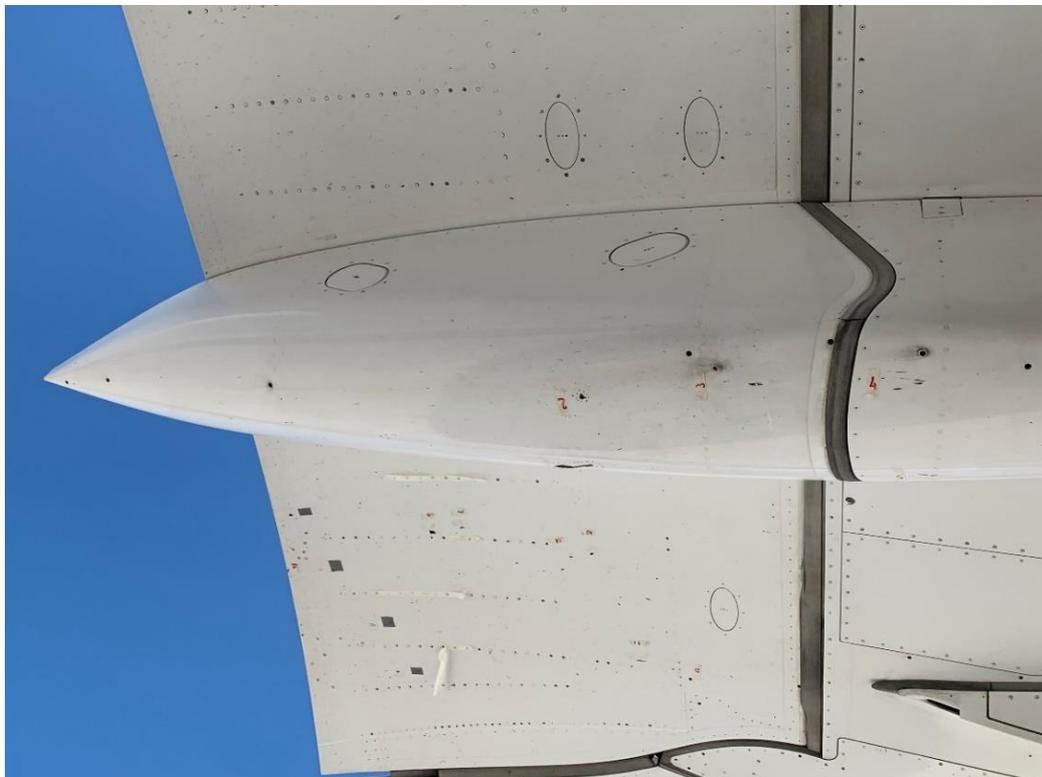
The aircraft showed holes and impact marks under flap # 2, flap fairing and on the horizontal stabilizer (photos 3-7). Several small impacts were also found on the fuselage (photo 8), mainly made of carbon fiber composite material. The tires of the left main landing gear deflated due to the high temperature induced by the braking as a result of the overweight landing (photo 9). Shortly after the event, borescope inspection was carried out on the left

Photo 3: damage to the flap.

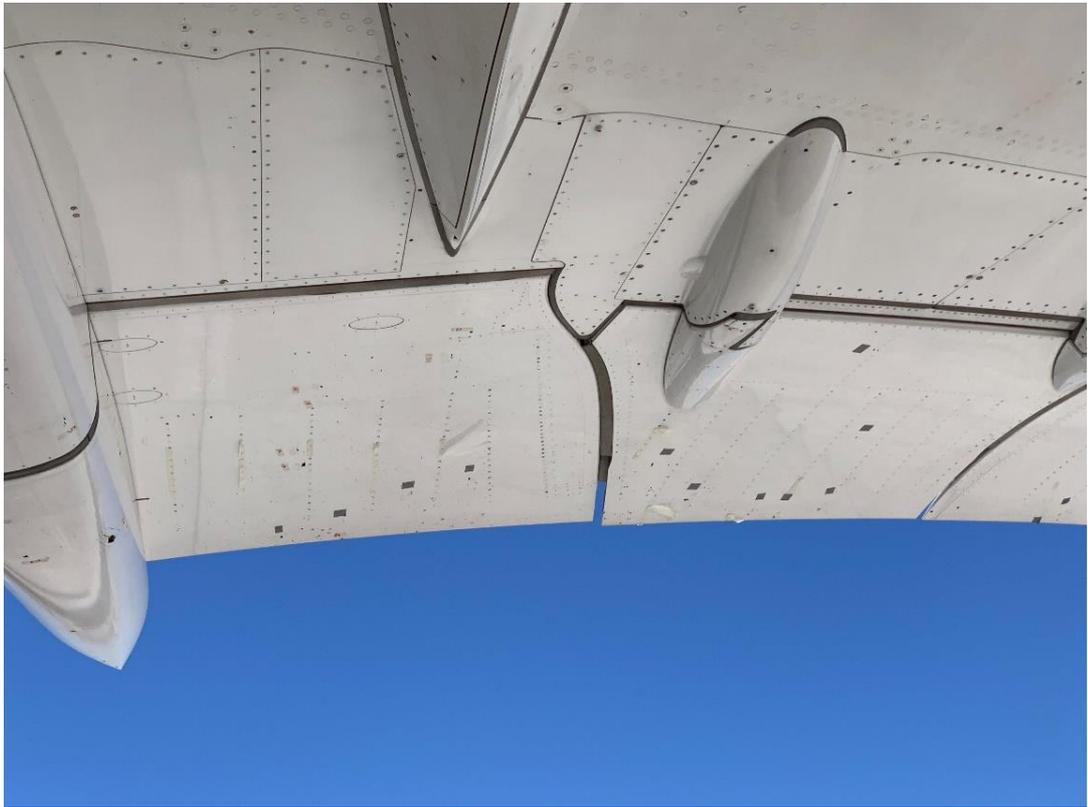
Photo 4: damage to the flap.

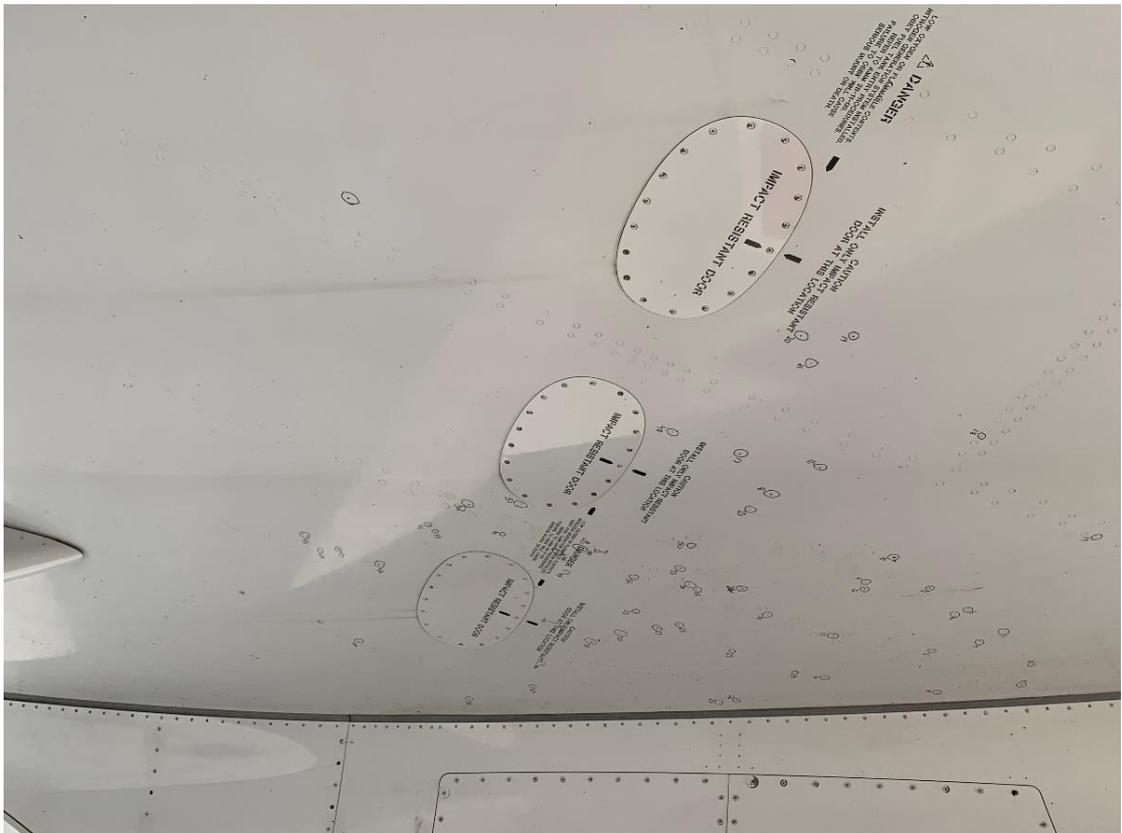
Photo 5: wing damage.

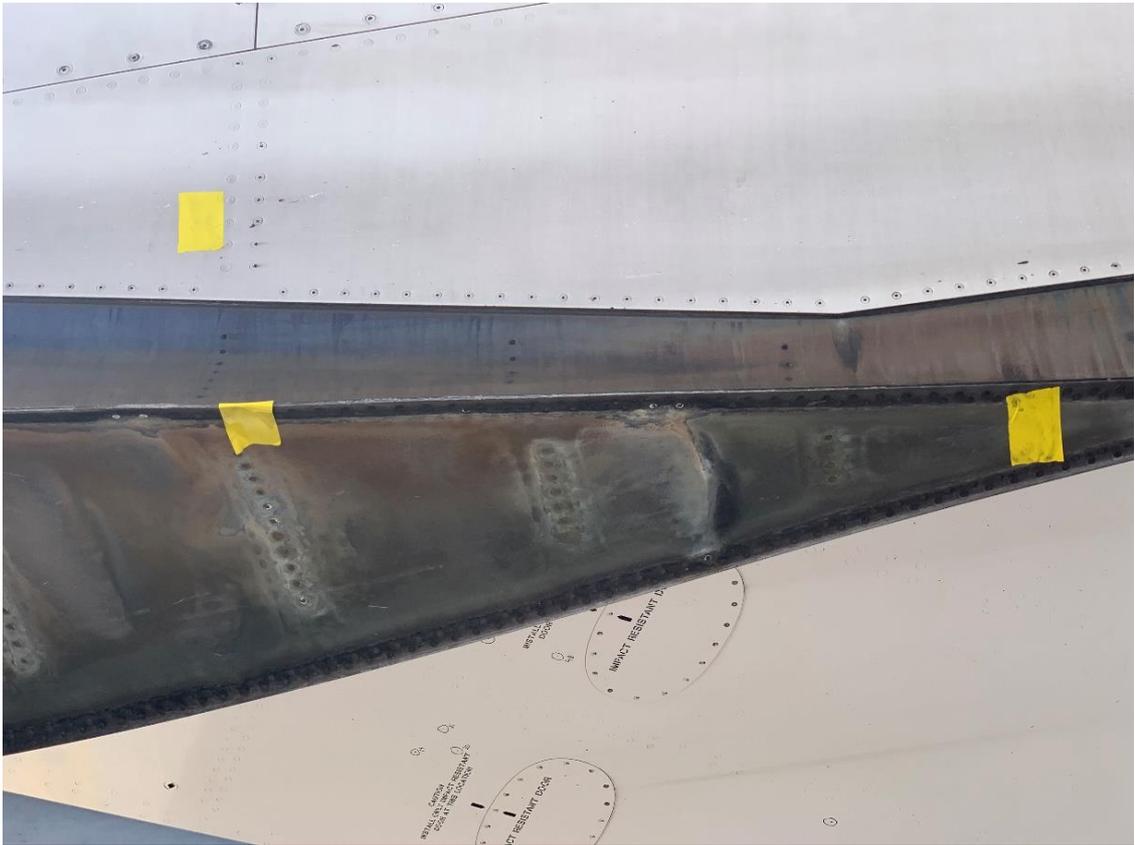
Photo 6: damage to the aft pylon fairing.

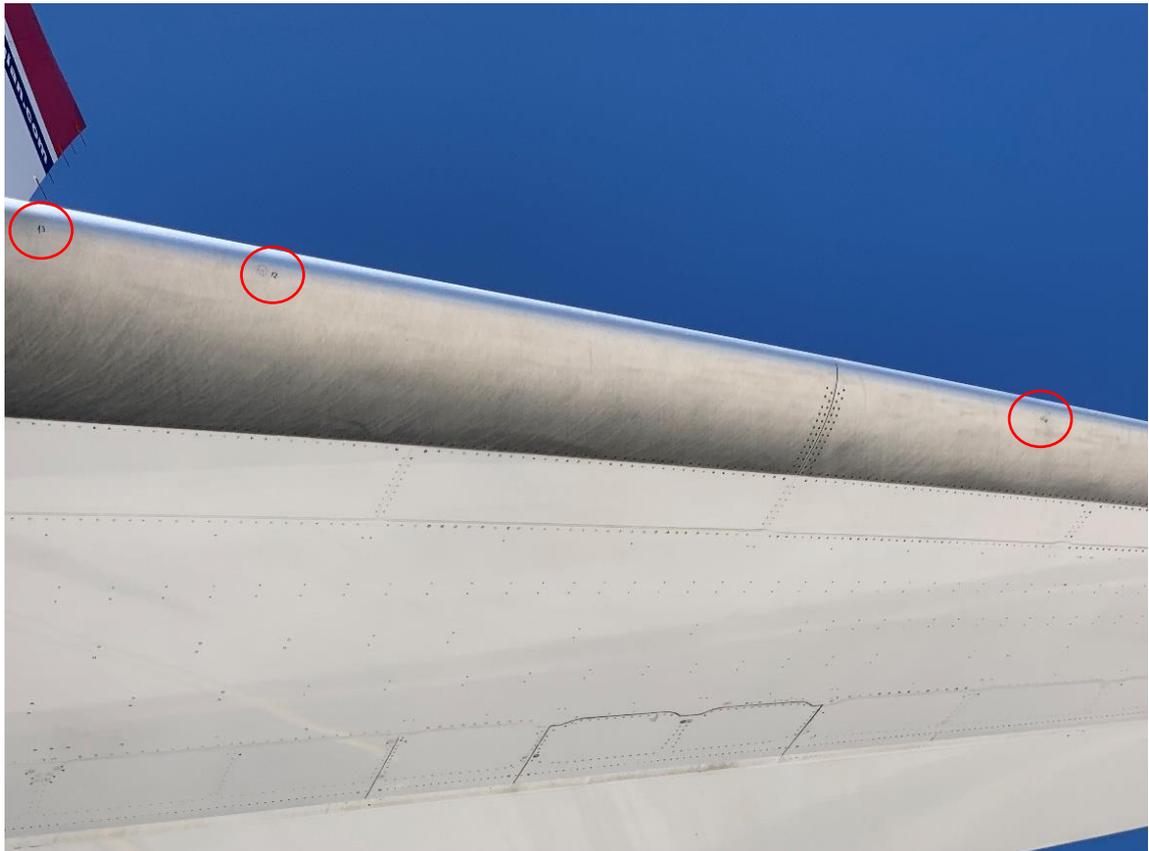
Photo 7: external damage of the horizontal stabilizer.

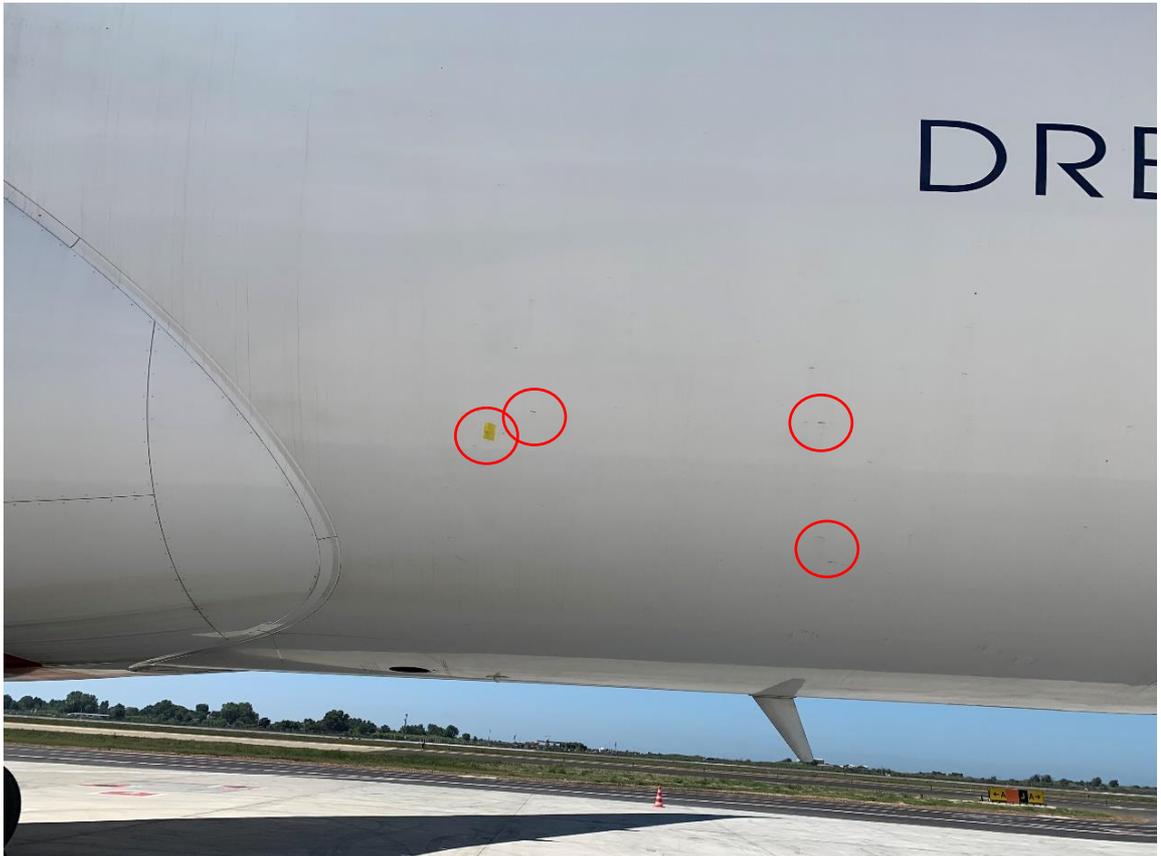
Photo 8: fuselage damage points.

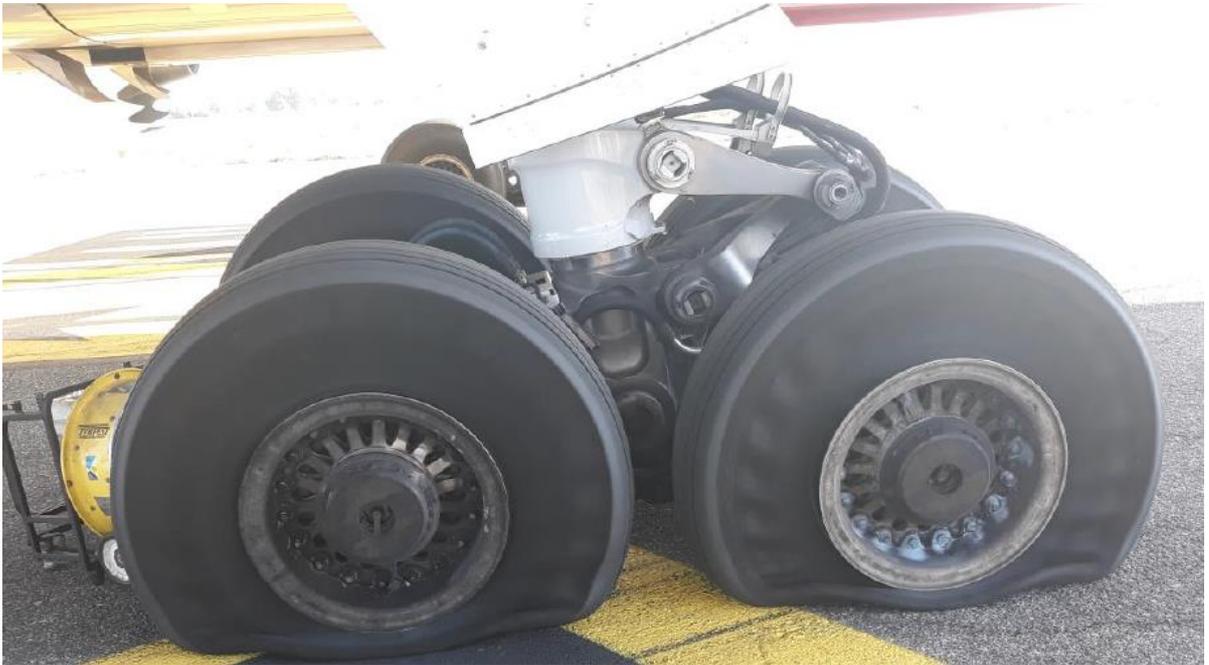
Photo 9: left main landing gear tires deflated.

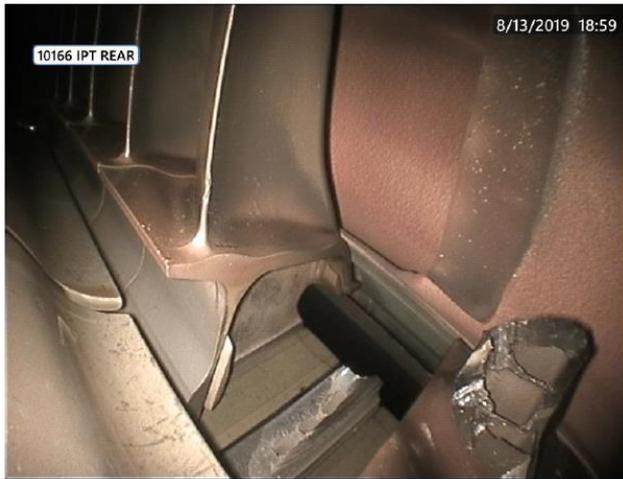
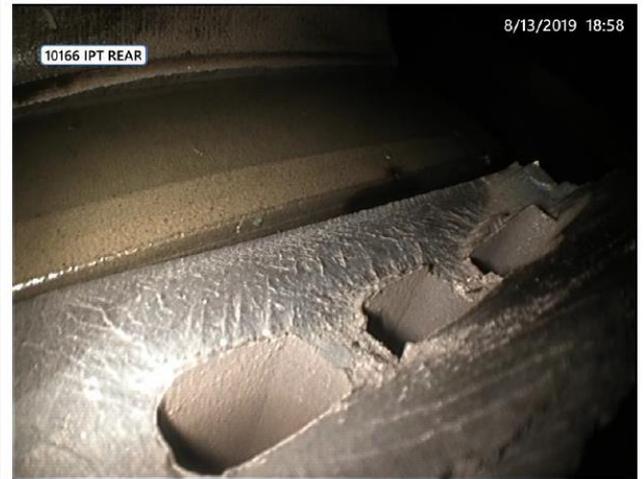
engine. This highlighted how the primary damage was generated by the detachment of an IPT blade (photo 10), which also caused the detachment of the trailing blade and subsequently a series of further damages, that will be described in detail in paragraph 1.16.

Photo 10: fracture surface of the primary damage consisting of the detachment of an IPT blade which led to the breakage of the adjacent one and then the further damage to the engine as described in paragraph 1.16.

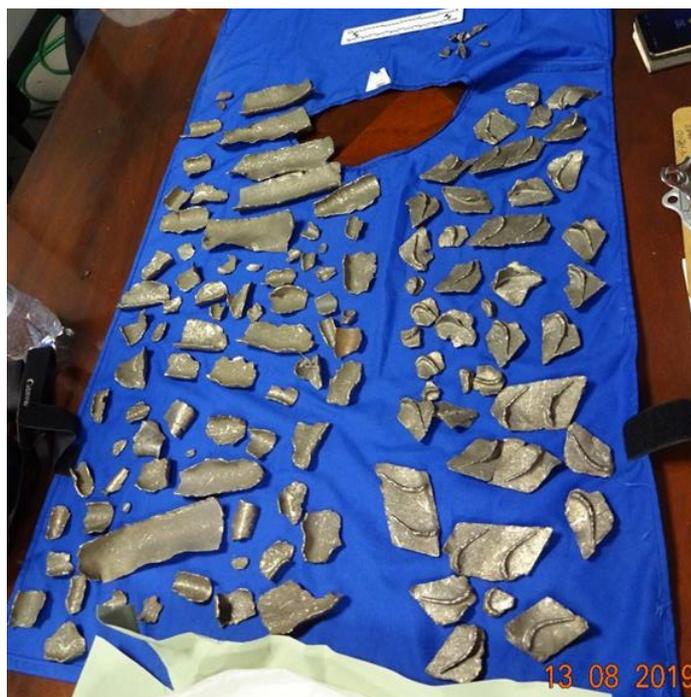
About 4 kg of debris (mainly fragments of turbine blades, photo 11) ejected from the left engine were recovered from the streets of Fiumicino (the city nearby the airport, detail in the red rectangle in figure 2), along the direction of the runway, where several damages to cars (mainly broken windows, photo 12, and indentations on the car body) and buildings (mainly holes in awnings) were reported by the population. No debris were found within the airport area. The larger fragments found weighed of about 100 g. The subsequent analysis of the engine made by the manufacturer suggested that about 38.2 kg was the total weight of the parts ejected from the engine.

Photo 11: fragments of turbine blades recovered from the streets of Fiumicino.

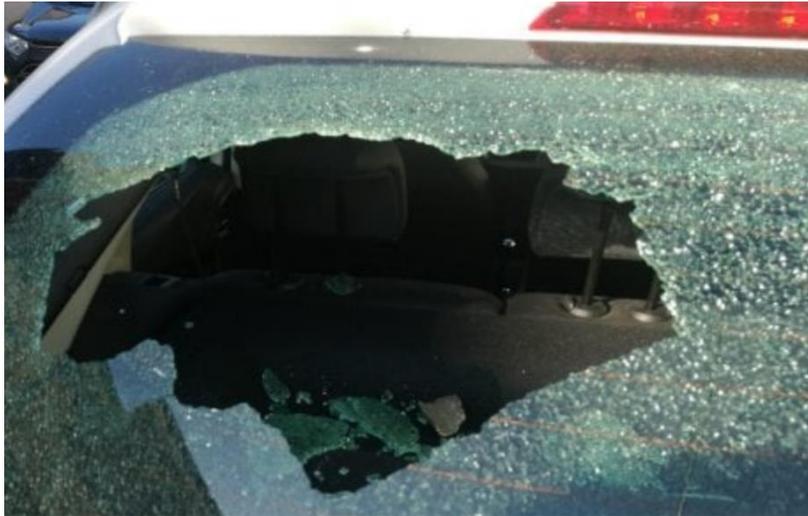
Photo 12: damage to a car (source Repubblica.it).

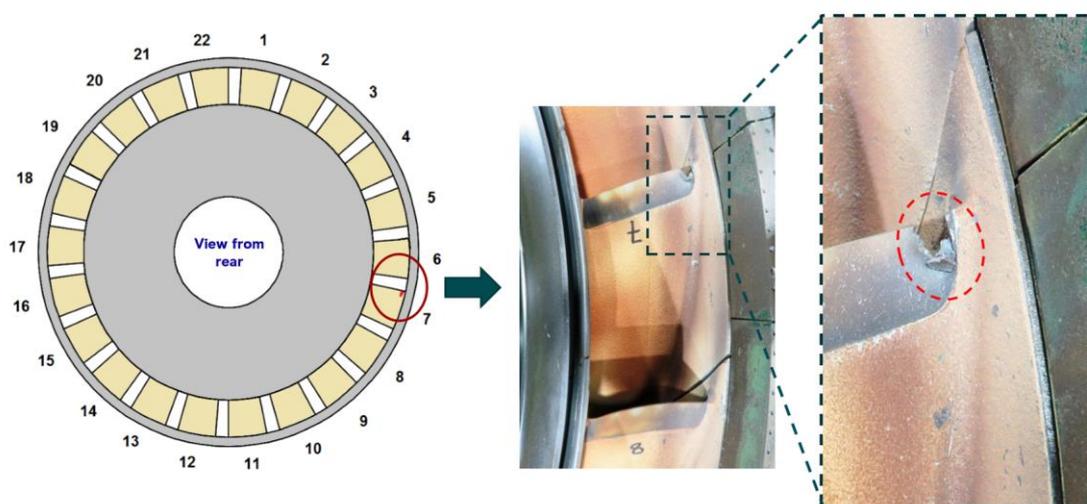
The NGV IPT stage is made of 22 vanes. One of these suffered slight damage on the trailing edge (figure 29). Regarding the IPT rotor stage, this consists of 114 blades. Most of them showed impact damage, mainly in areas other than the leading edge. Only the blade in position number 79 failed below the base platform (photo 14). The trailing blade, n.80, was also fractured but above the base platform. The failure analysis of the detached blade, which was placed in position n °79, will be presented in the next paragraph.

Figure 29: NGV IPT damage.

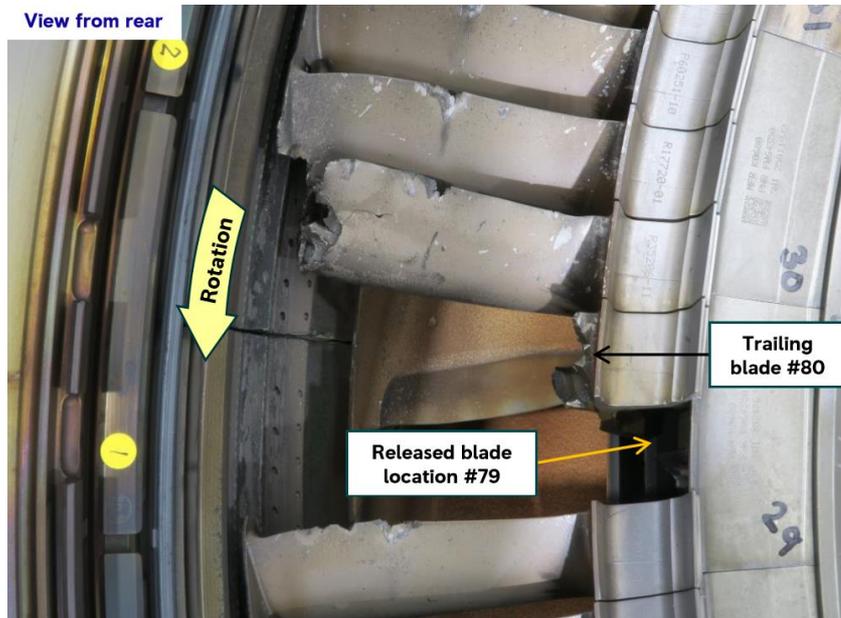
Photo 14: IPT damage.

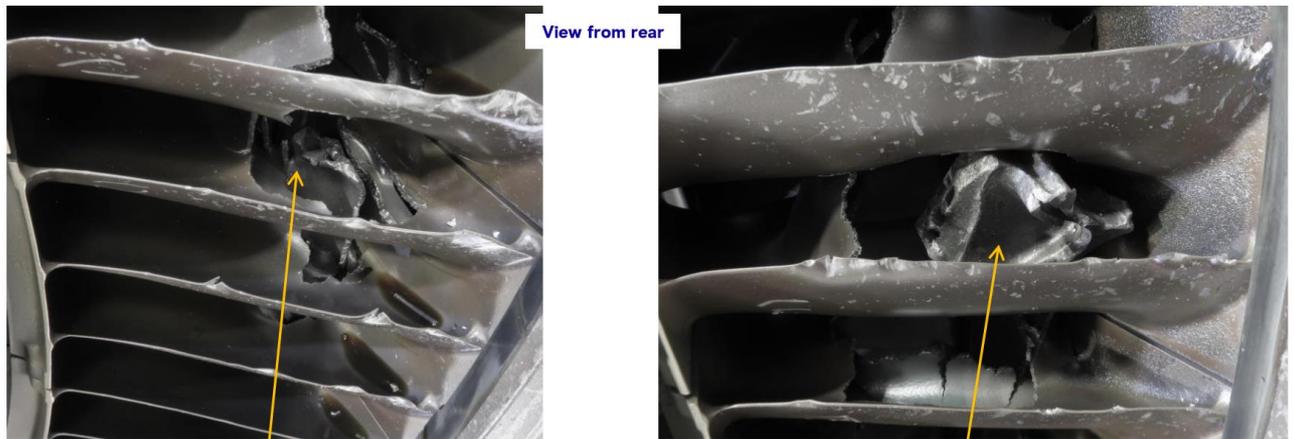
Photo 15: IPT fragments blocked in the LPT NGV.

Two fragments of IPT blade remained stuck in the first LPT NGV (photo 15). Extensive damage to the LPT discourager seal (photo 16) was probably caused by the displacement of the platform of the IPT 79 blade.

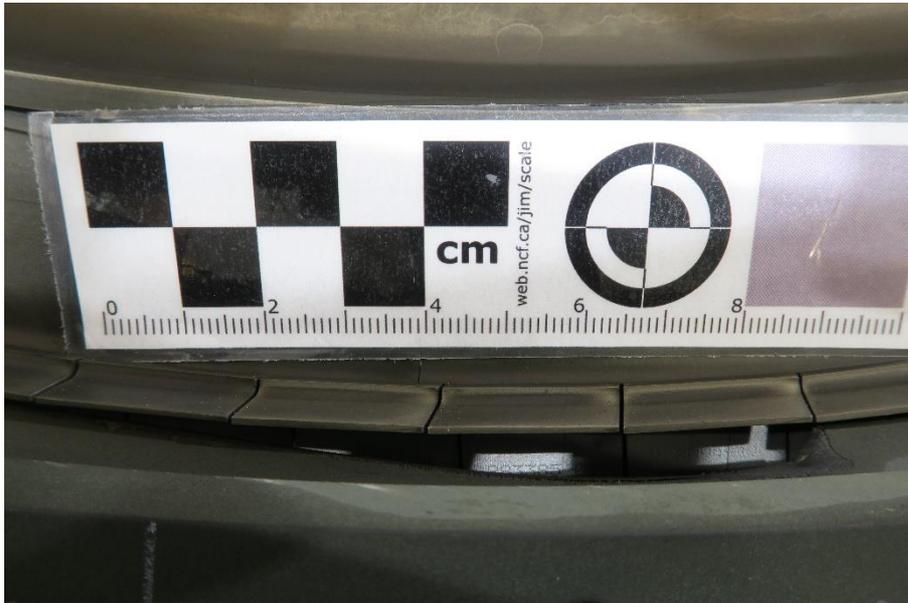
Photo 16: discourager seal damage.

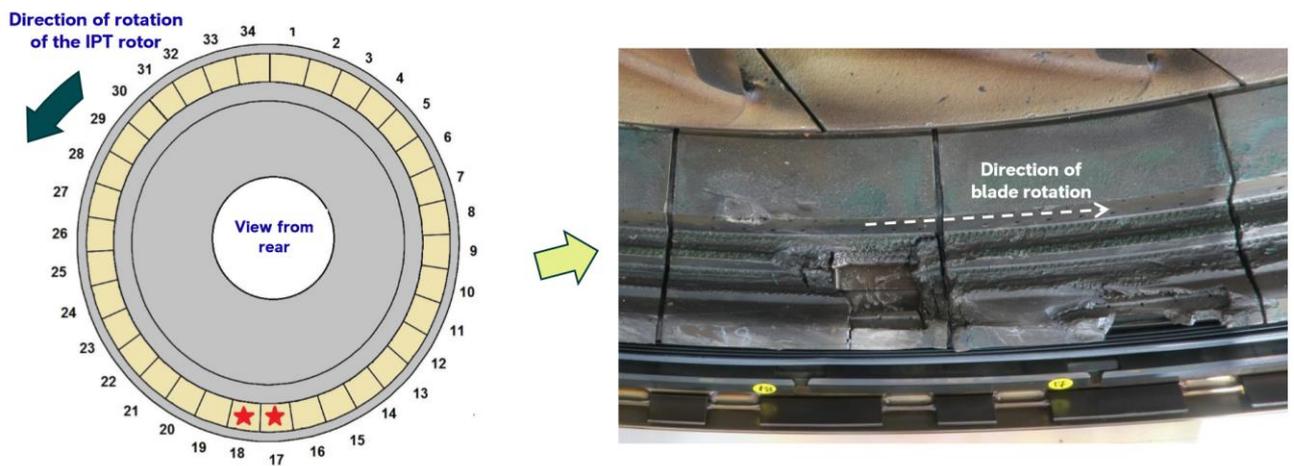
Figure 30: damage to the seal segment of the IPT stage.

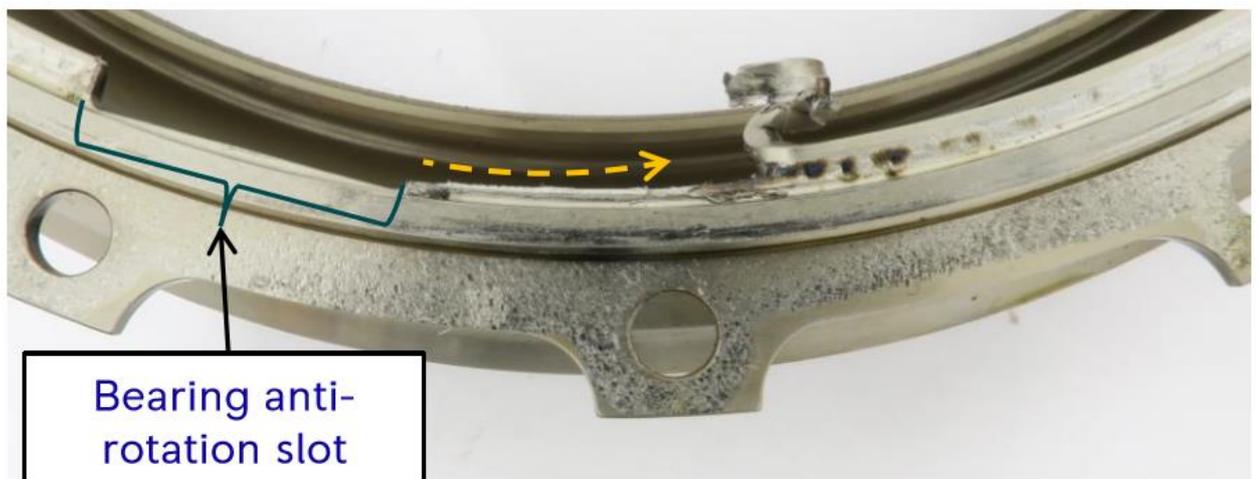
The IPT roller bearing retainer was fixed by 15 bolts, all found with a tightening torque lower than expected. This is most likely due to the anomalous stresses that acted on the assembly. The 4 roller bearing anti-rotation slots were found deformed (photo 17).

Photo 17: anti-rotation slots.

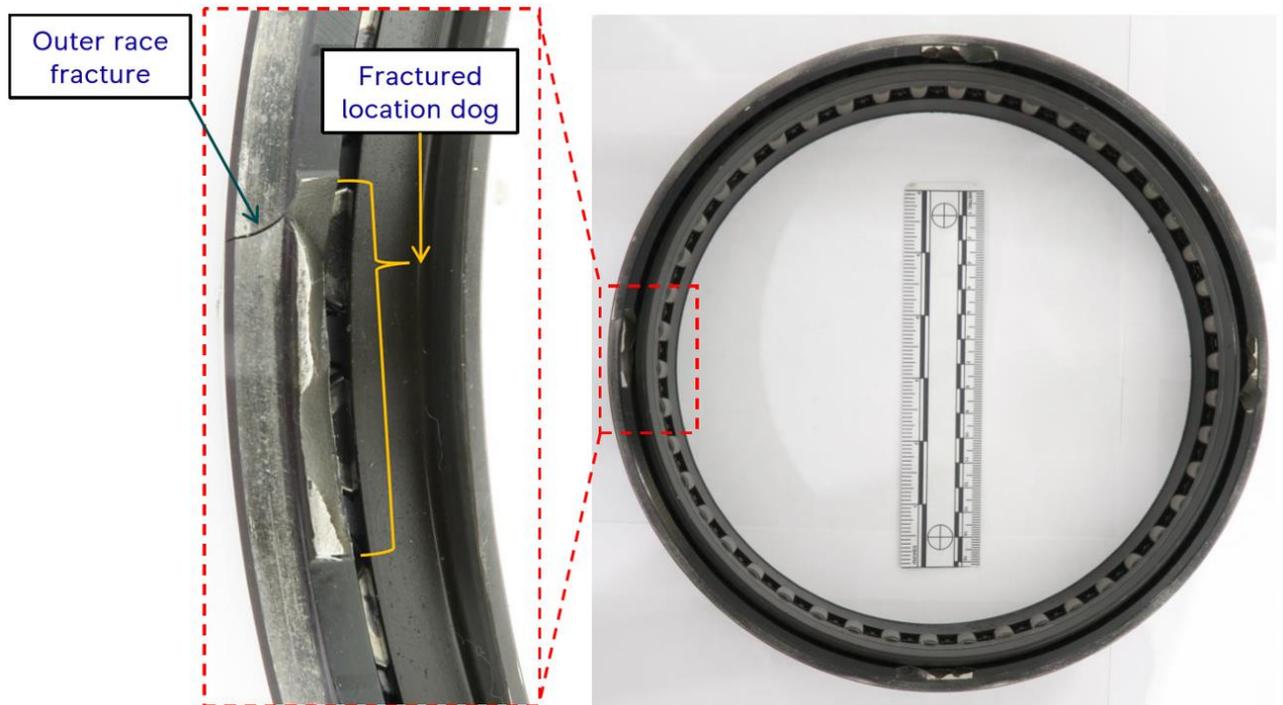
Fretting marks were also observed on the bolted flange faces. Also on the IPT bearing, deformations and damage on the (anti-rotation) locations dogs were observed (photo 18). However, the bearing appeared to be in good condition: all the cylinders moved freely.

Photo 18: damaged (anti-rotation) location dogs.

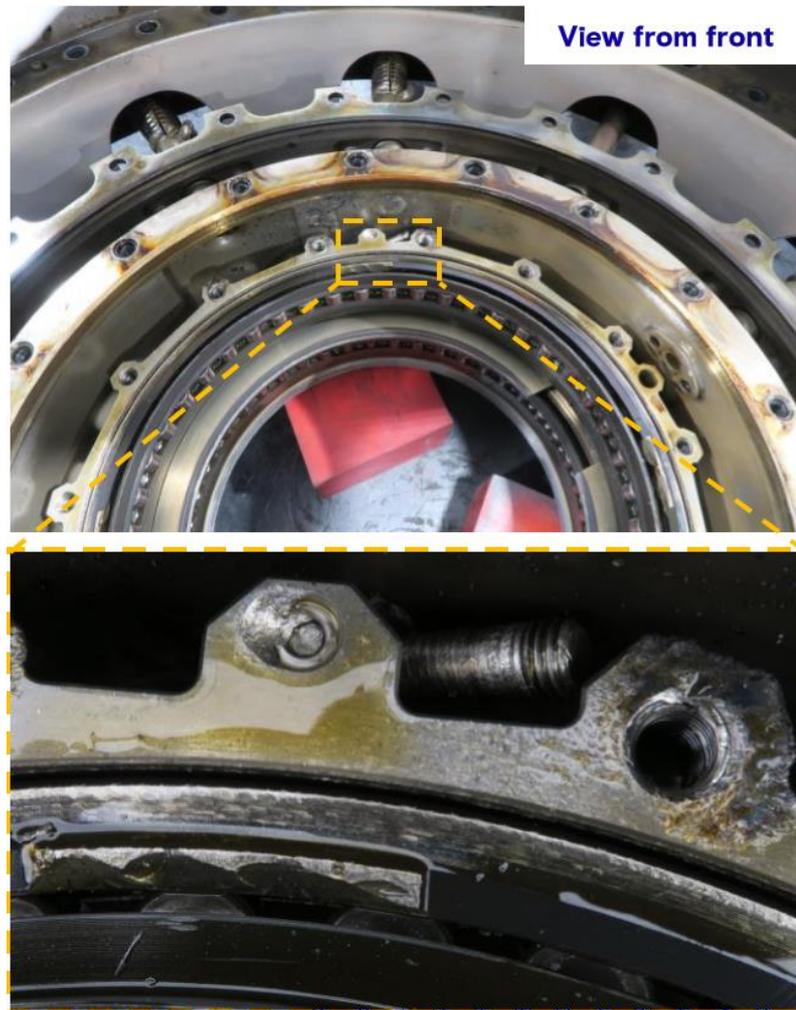
About the high pressure bearing, all 15 fastening bolts were found to have released due to abnormal stresses suffered during the event. The relative housing holes were also found deformed and damaged (photo 19).

Photo 19: deformation of the holes for the HP bearing fixing bolts.

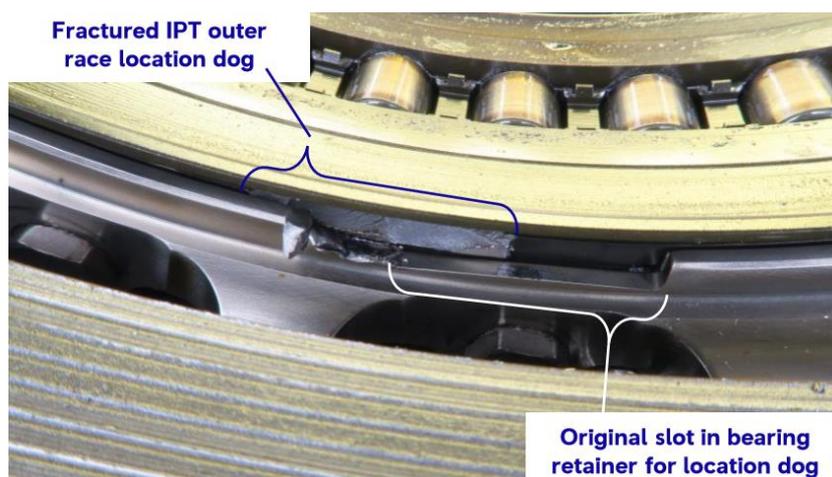
The HP bearing showed the same damage already observed for the IP bearing at the anti-rotation slots (photo 20).

Photo 20: damaged anti-rotation slots.

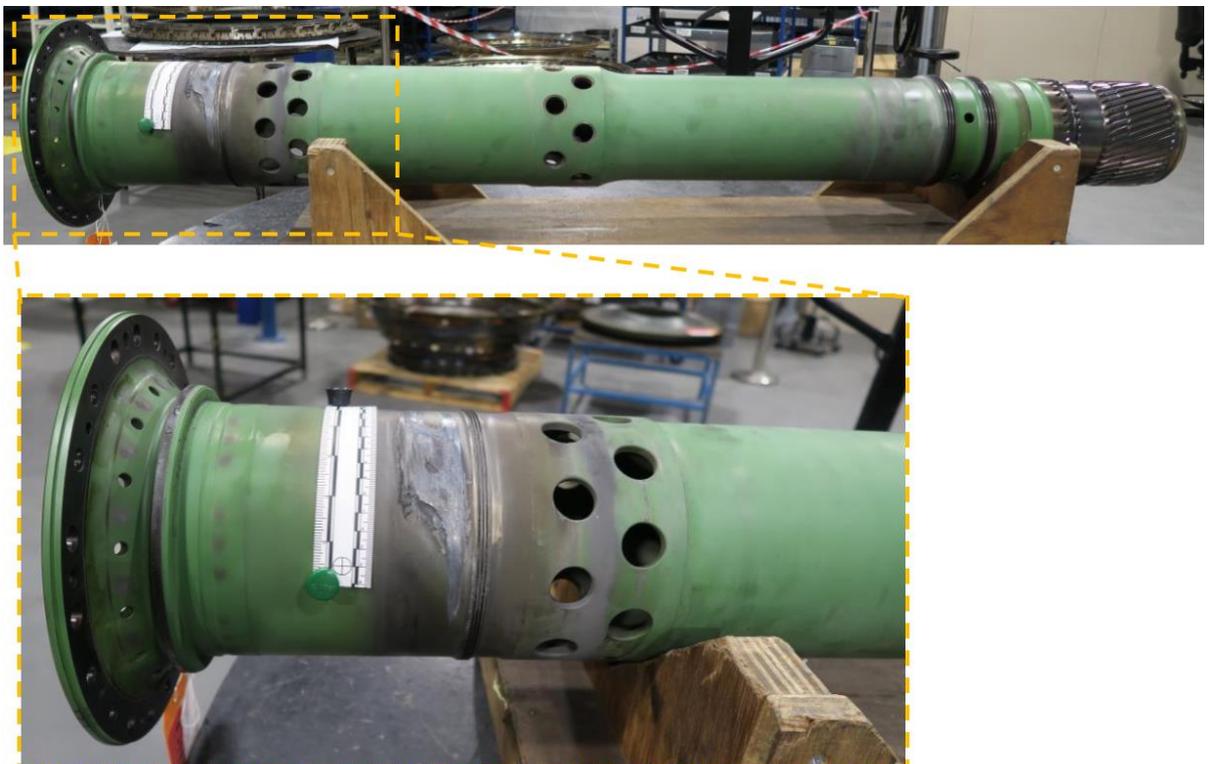
Photo 21: IPT shaft damage.

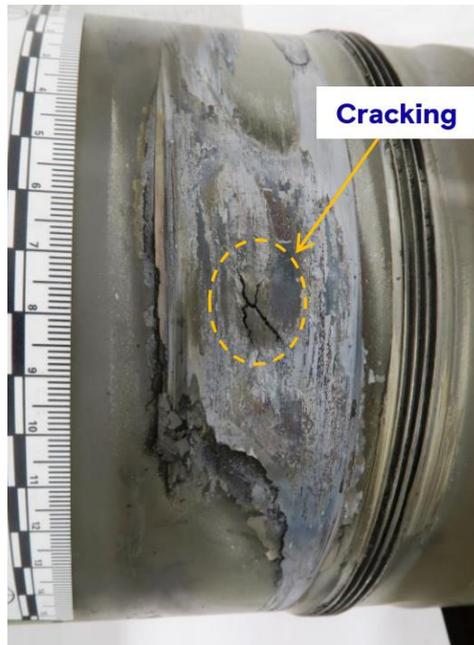
found (photo 22). Similar damage was found on same earlier events. This was assessed by the engine manufacturer to understand the cause and identify any potential safety concerns. The original assessment concluded the observed damage was a secondary effect of the IPT blade release, being caused by rubbing due to the IPT rotor being out of balance when the blade released at certain operating conditions. The localized frictional heating of the shaft resulted in the cracking and no subsequent fatigue propagation was found. Based on the shaft design and experience of other turbine blade releases in other engine types, the assessment concluded that there was very little risk of shaft separation if any future IPT blade release events occurred. The details of the event and damage on 10166 were compared to those which had previously been analyzed and it was concluded by the manufacturer that the damage was consistent with previous experience.

Photo 22: IPT shaft damage.

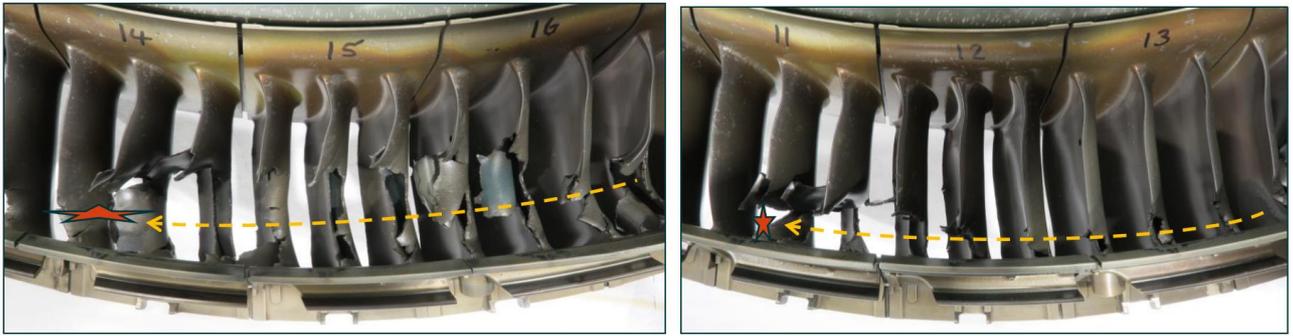
Regarding the LPT1 NGV stage, it is made up of 34 sectors each one 3-off vanes per pack, for a total of 102 vanes. The greatest damage was found to the leading edges through an arc of  $\sim 80^\circ$  between sector 11 and 18 (figure 32 and photo 23, the trajectories of the fragments that caused the damage are also illustrated). All the rest are also damaged to a lesser degree.

Photo 23: LPT1 NGV damage.

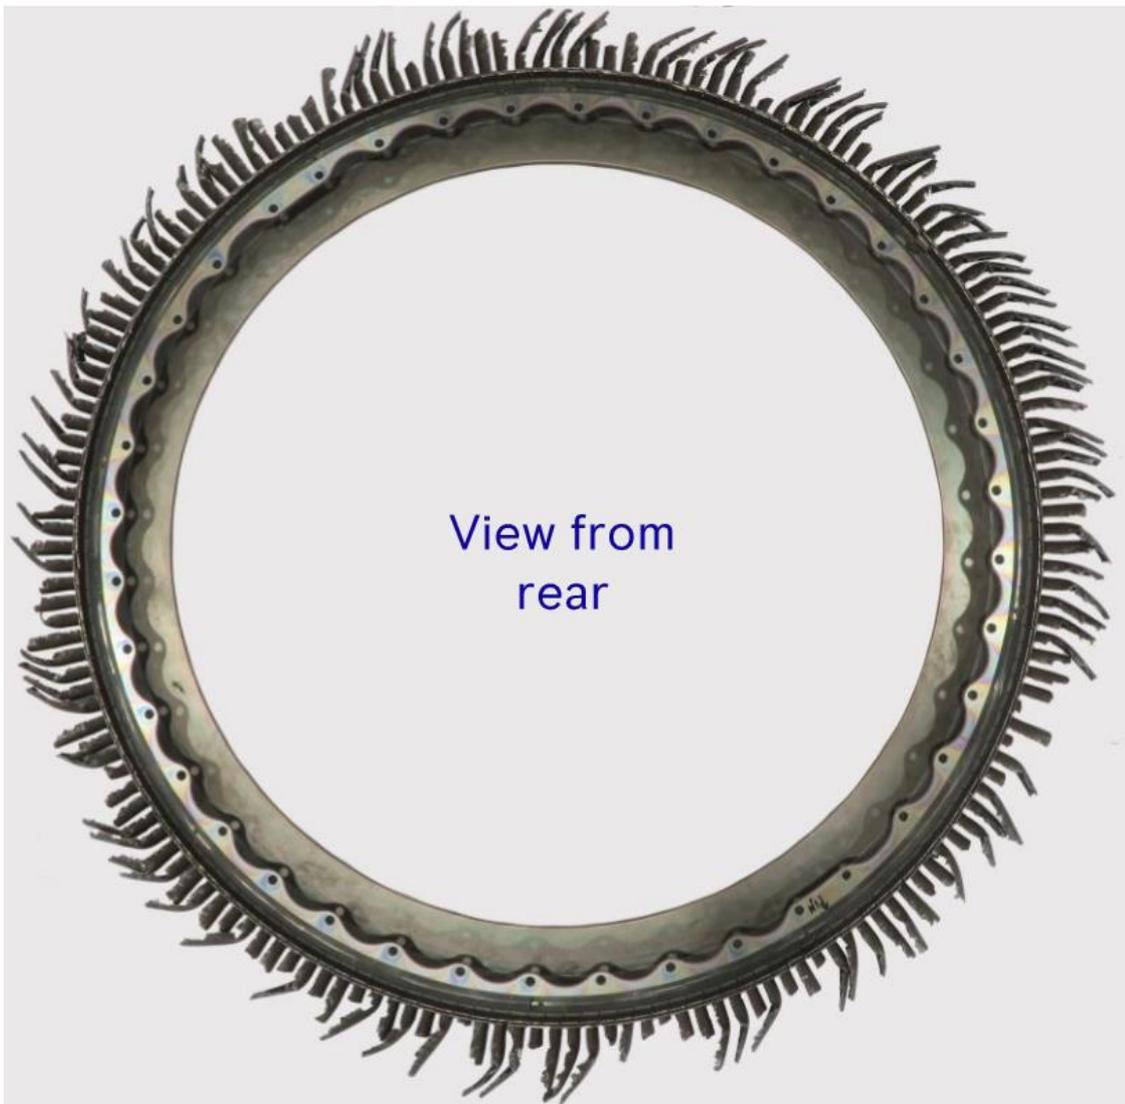
Photo 24: 1st stage LPT rotor damage.

The first rotor stage LPT consists of 170 blades in sectors of two. It is evident that a lot of material from the blades is missing and on the almost intact blades there are conspicuous deformations (photo 24). Similar evidence can be observed on all the successive guide vanes and rotor stages (photos 25-31). In the 2nd stage LPT seal segments, the projection of a fragment created a through thickness indentation on the containment case (photo 27 and photo 32). However no fragment exited through the casing.

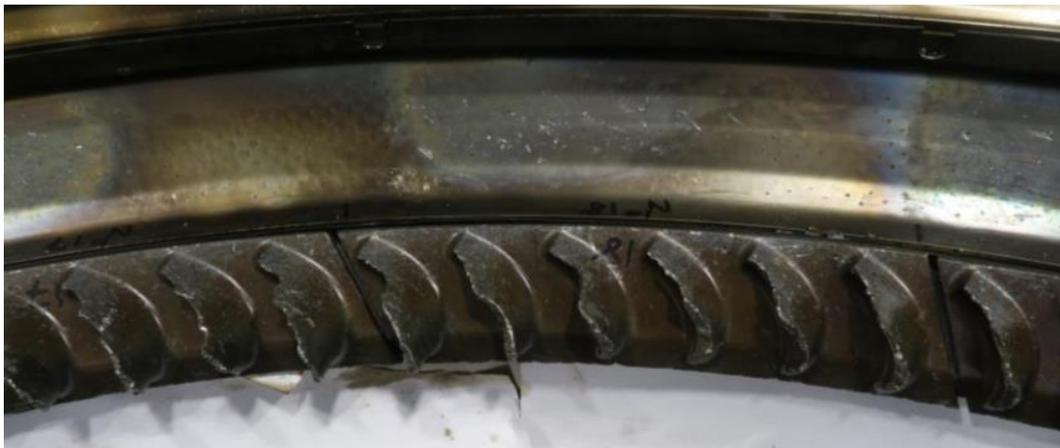
Photo 25: damage to NGV 2nd stage LPT.

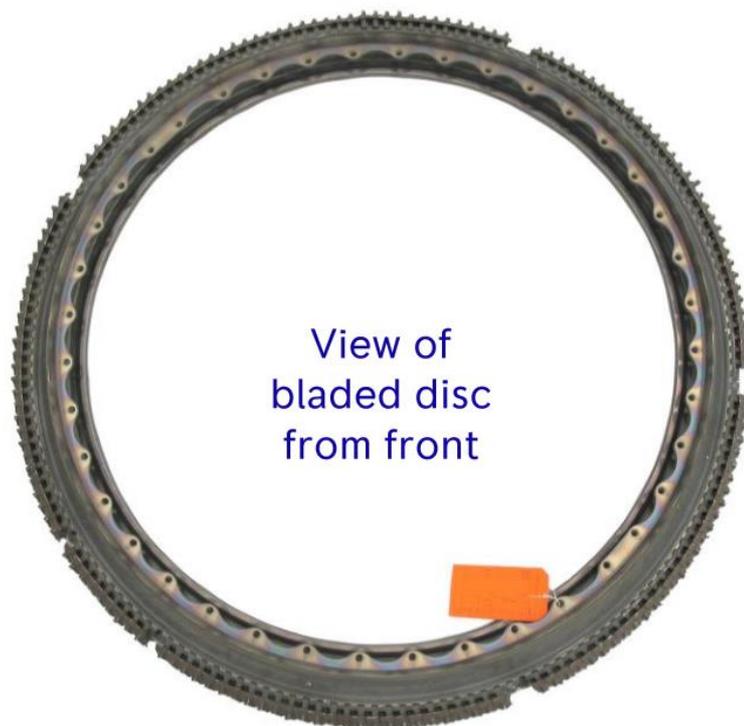
Photo 26: 2nd stage LPT rotor damage.

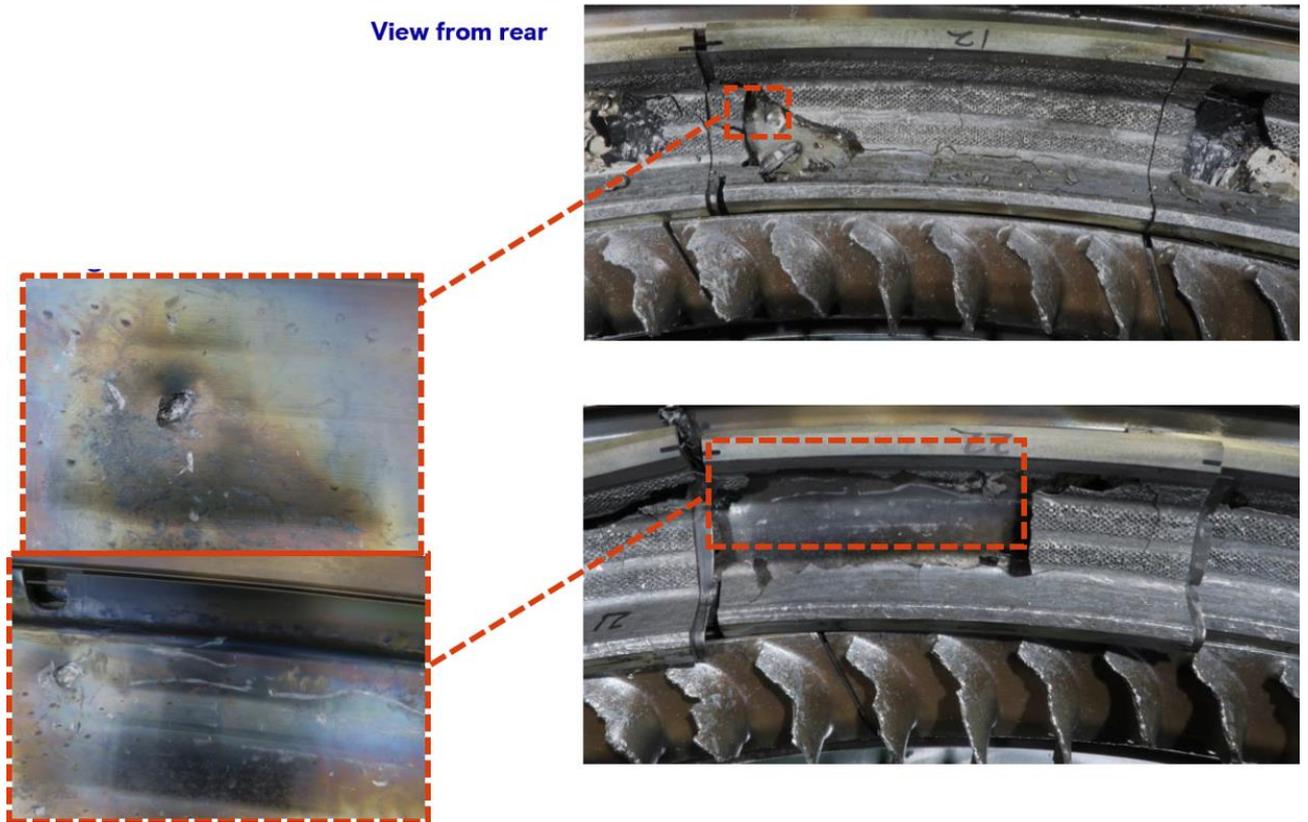
Photo 27: damage to 2<sup>nd</sup> stage LPT seal segments.

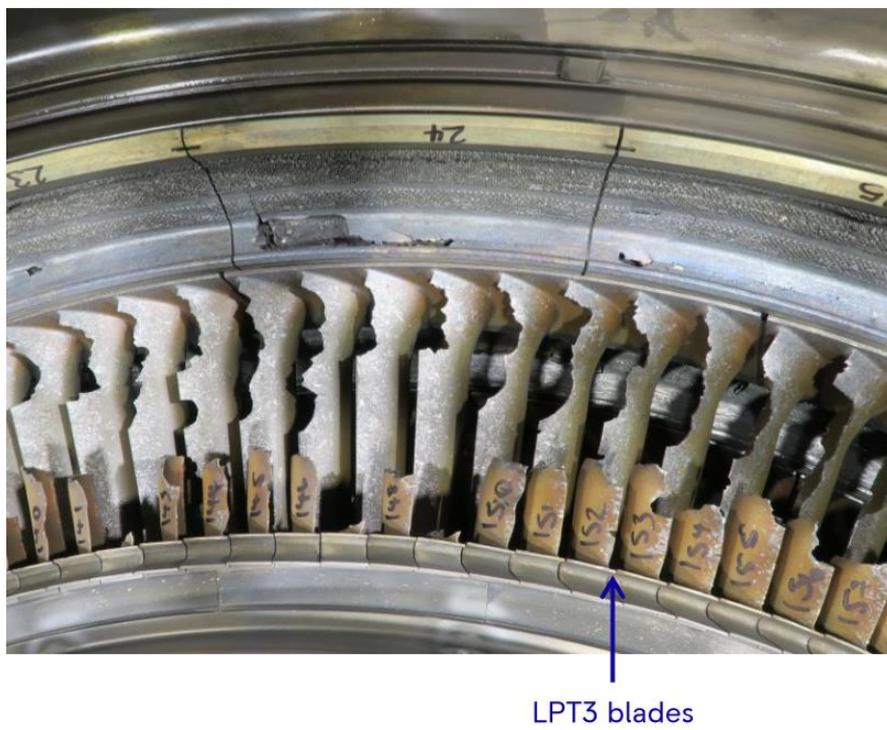
LPT3 blades

Photo 28: LPT 3<sup>rd</sup> stage damage.

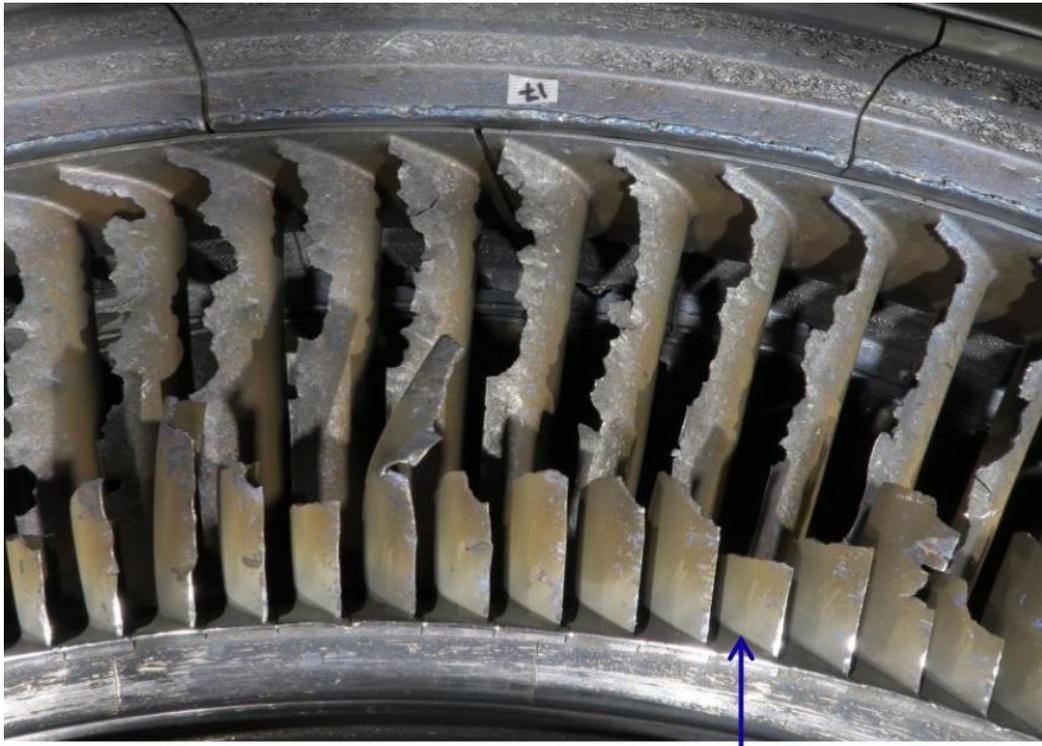
LPT4 blades

Photo 29: LPT 4<sup>th</sup> stage damage.

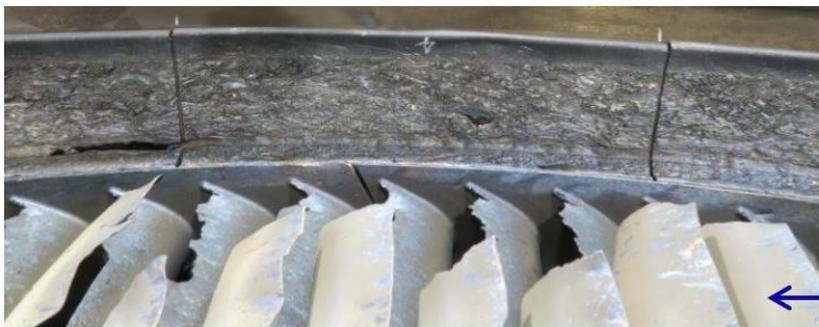
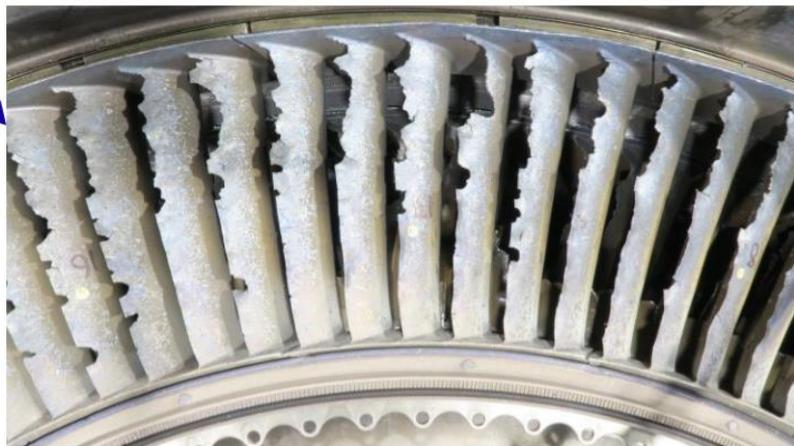
LPT5  
blades

Photo 30: LPT 5<sup>th</sup> stage damage.
