# **FINAL REPORT**

**SERIOUS INCIDENT**  
**Aircraft B787-8 registration marks LN-LND,**  
**Rome Fiumicino International Airport, Italy,**  
**10<sup>th</sup> of August 2019**

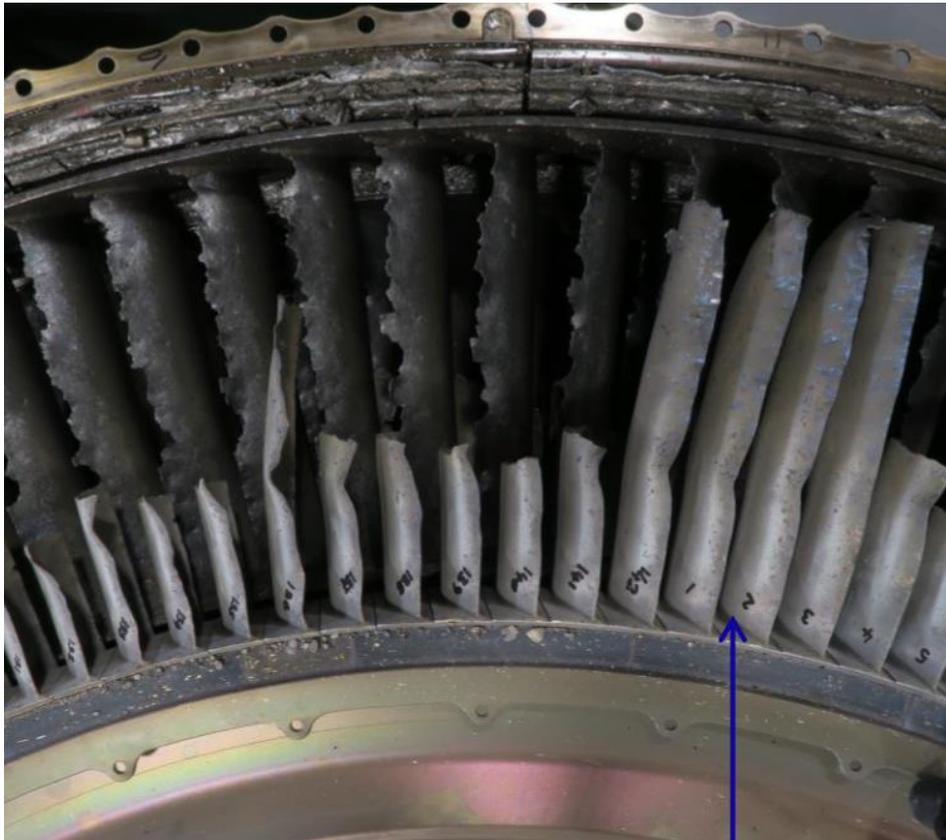
Photo 31: damage to the 6<sup>th</sup> stage LPT.

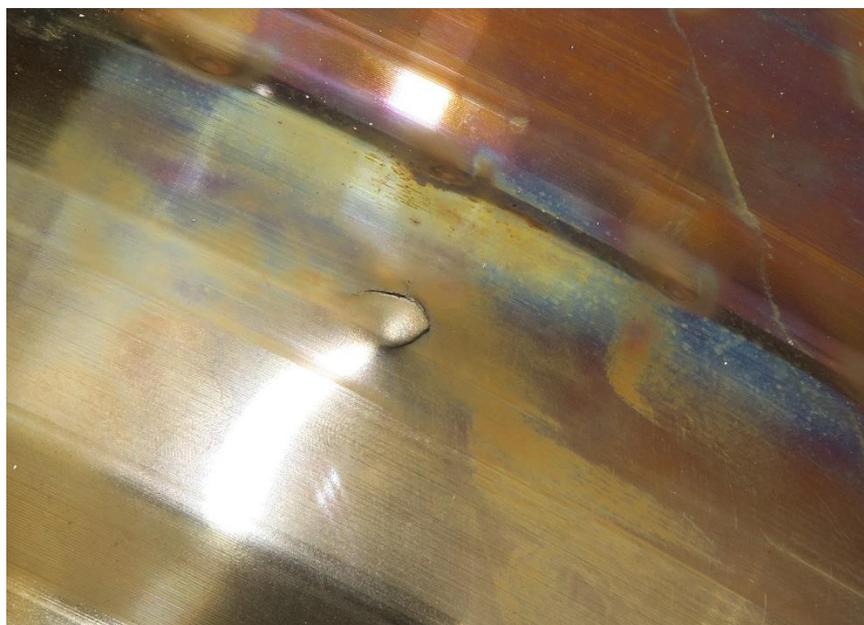
Photo 32: through thickness indentation 2<sup>nd</sup> stage LPT.

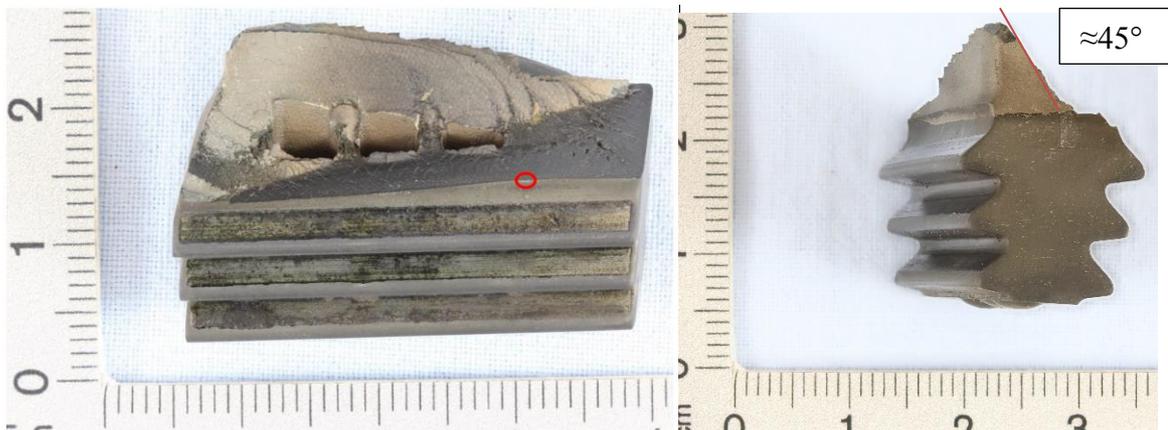
In detail, the fracture surface of the aforesaid blade showed two distinct areas. The first, planar, was associated to the progressive part of the fracture (about 37% of the total cross section) and a part of progressive overload. The remaining part was oriented at about 45° (photo 33) and was associated to the overload occurred when the resistant section was no longer sufficient to withstand the applied loads. The progressive part of the fracture surface had a maximum depth of about 6.03 mm. That area appeared to be smooth as well as the area oriented at about 45°.

Photo 33: fracture surface.

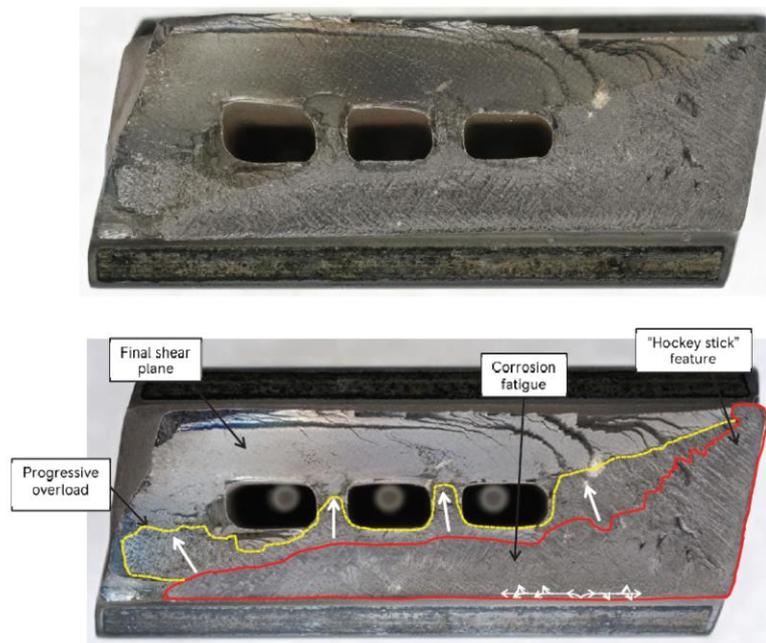
Photo 34: fracture surface.

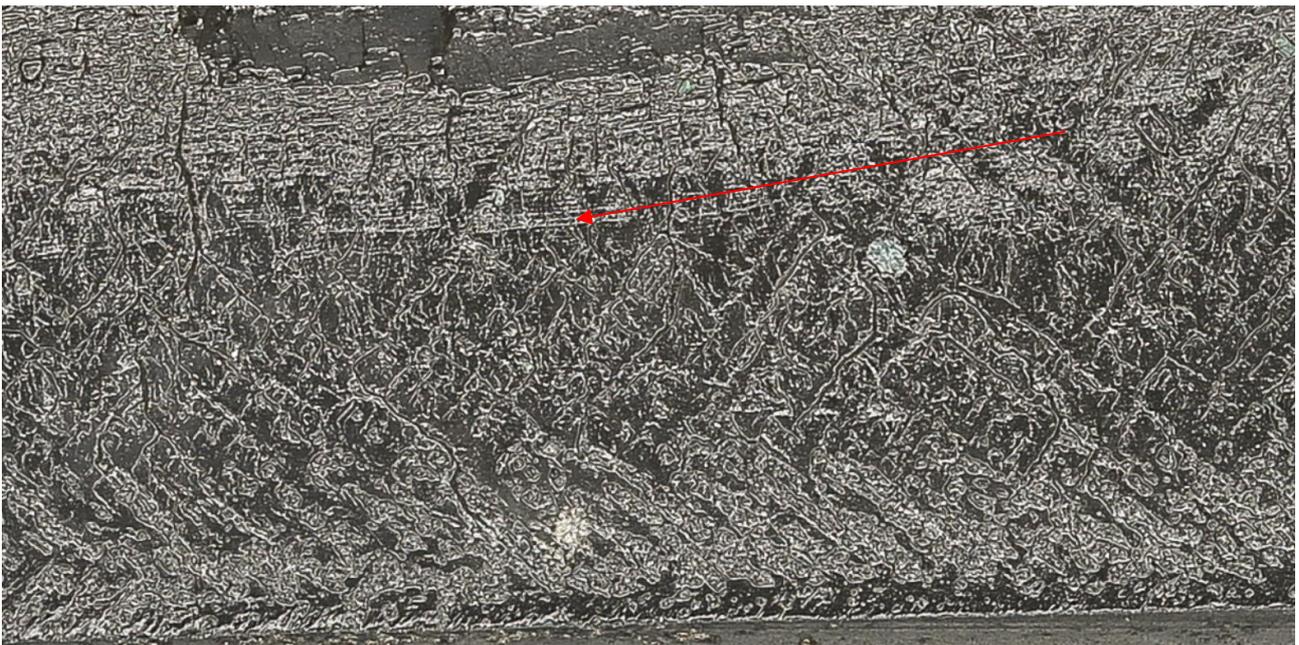
At the depth of approximately 5 mm the morphology of the crack changed and become stepped in appearance (arrow photo 35); these stepped features were parallel and block like and considered typical of progressive overload.

Photo 35: fracture surface detail.

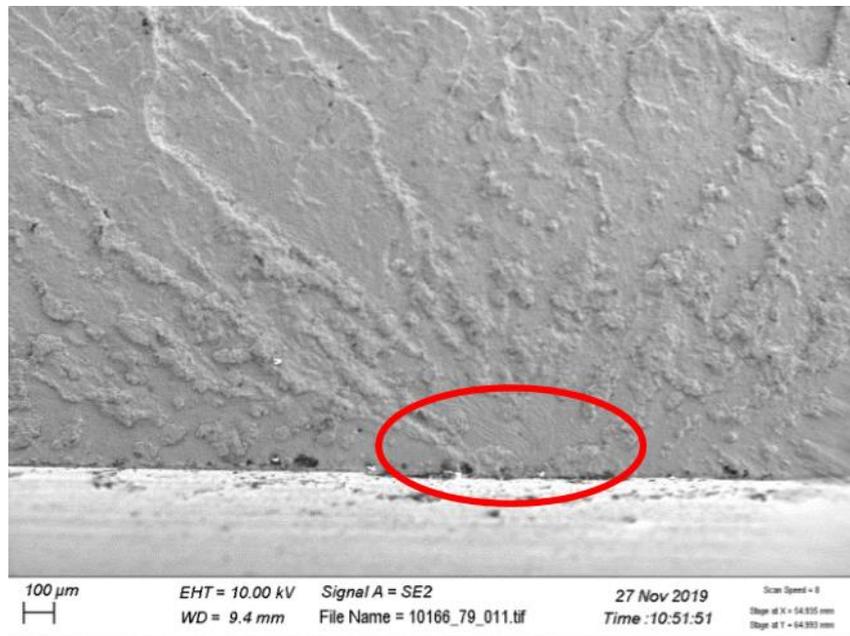
Photo 36: initiation.

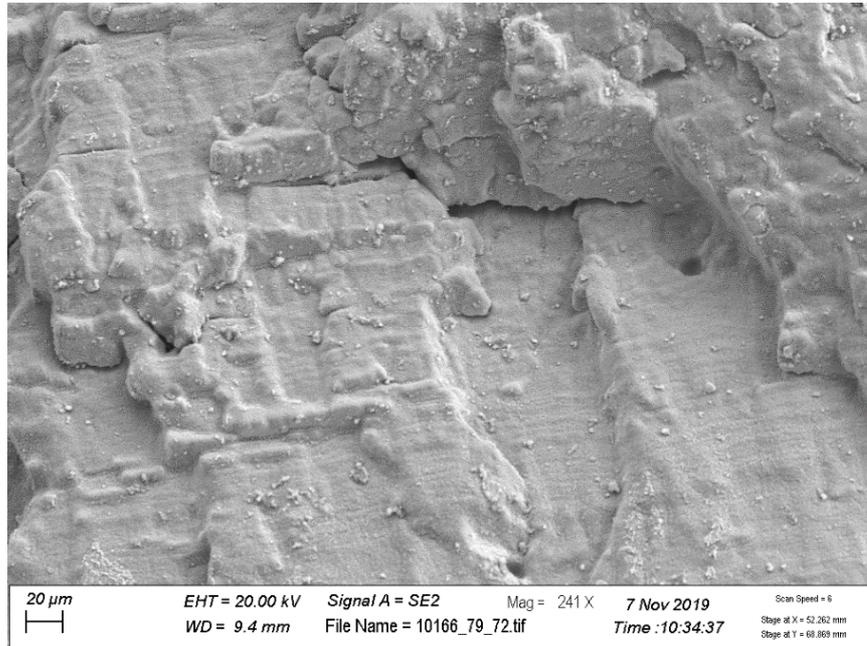
Typical fatigue striations were clearly visible at the crack tip (photo 37), whose spacing, varying greatly from area to area (photo 38). However this feature was not observed in the bulk propagation making impracticable a detailed life estimation.

Photo 37: fatigue striations.

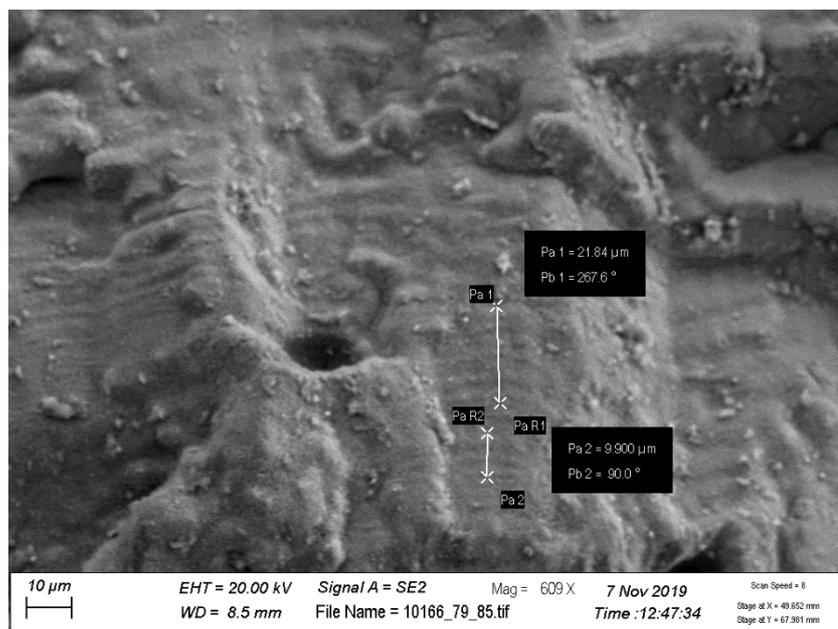
Photo 38: measurements for the calculation of striation spacing.

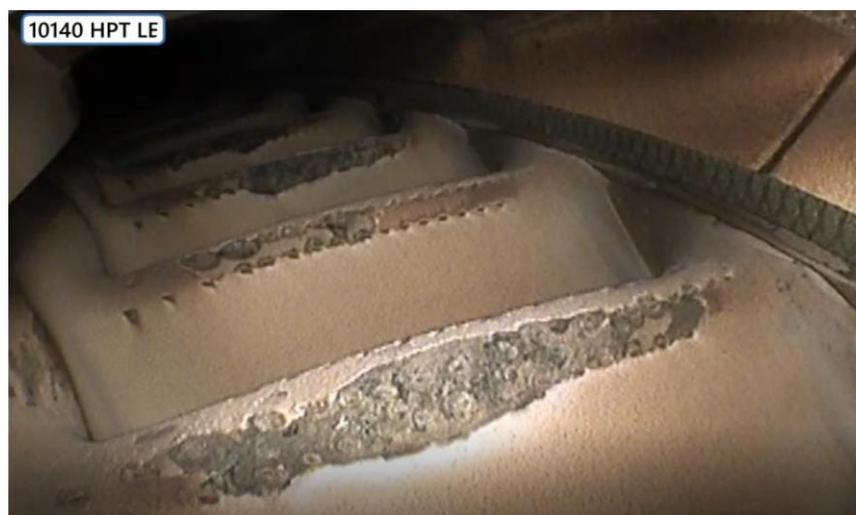
Borescope inspection of the right engine showed no damage. Some signs of erosion (photo 39) were found in the high pressure turbine blades within acceptable limits for continued operation. Signs of rework were also found on the LPT blades (photo 40) carried out in a previous shop visit at the manufacturer and authorized by technical variance.

Photo 39: erosion on the HPT blades.
