Collision with water involving Cessna 208 Caravan, VH-WTY

Thomson Bay, Rottnest Island, Western Australia, on 7 January 2025

ATSB Transport Safety Report
Aviation Occurrence Investigation
AO-2025-001
Preliminary – 27 February 2025

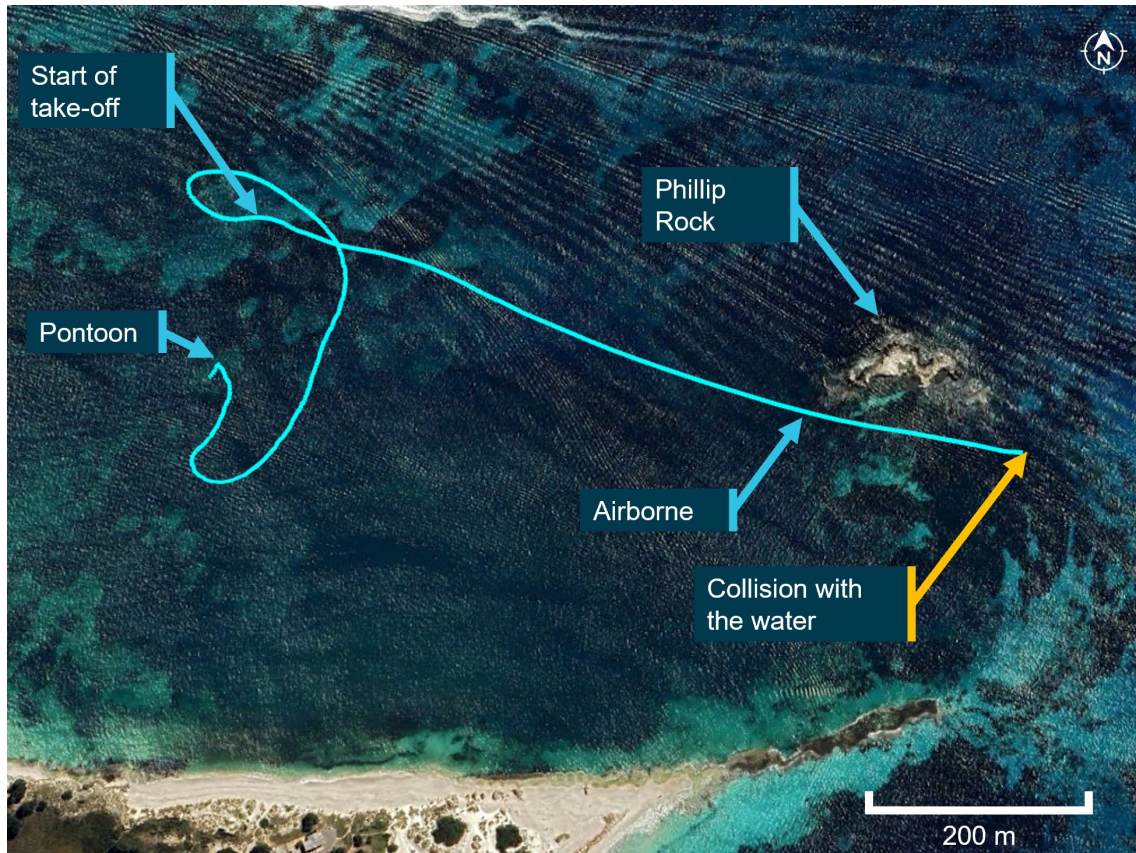
Figure 2: VH-WTY take-off track with approximate location of key events

Flight data showed at 1600:20 engine power was applied for the take-off. Over the following 32 seconds, the aircraft travelled along the surface of the water in an easterly direction. Witness video and the flight data showed that at 1600:52,¹ as the aircraft approached the western tip of Phillip Rock it became airborne with a high nose attitude. At 1600:58, the aircraft rolled rapidly to the left with the left wingtip and then fuselage impacting the water. Further description of the aircraft behaviour during the take-off sequence is described in *Recorded information*.

- Engine power was applied to commence the take-off at 1600:20, with the aircraft about 600 m from the western tip of Phillip Rock, and at a heading of 108°.
- Fifteen seconds into the take-off the aircraft had accelerated to 40 kt and was about 400 m from Phillip Rock. The aircraft transitioned onto the step⁵ and the nose was lowered. The aircraft heading was manoeuvred on a course between Phillip Rock and the eastern tip of Thomson Bay.
- About 200 m from Phillip Rock, and with a recorded airspeed of 46 kt, the aircraft appeared to cross a wave or swell. Video footage showed the aircraft appearing to bounce on the water, becoming airborne momentarily before settling back onto the water.

- Over the next few seconds, the left wing rose on 2 occasions as the aircraft approached Phillip Rock, with the left float separating from the water. On each occasion, the aircraft struck waves and the right float did not separate from the water.

- There was a gradual reduction in engine power for about 20 seconds, commencing prior to the aircraft becoming airborne.
- About 30 m from Phillip Rock, the aircraft had accelerated to a recorded airspeed of 57 kt, and again appeared to strike waves.

- At 1600:52, the aircraft then became airborne, with a nose high attitude and on a heading of about 110°. Over the next few seconds, the aircraft maintained a nose-up attitude of between about 15°– 18°. The aircraft climbed to about 16 ft above the surface of the water. The right wing then dropped, followed by an apparent aerodynamic stall of the left wing, with the aircraft rolling to the left.

- At 1600:56 the engine torque increased rapidly.
- At 1600:58 the left wingtip struck the water then followed by the fuselage.

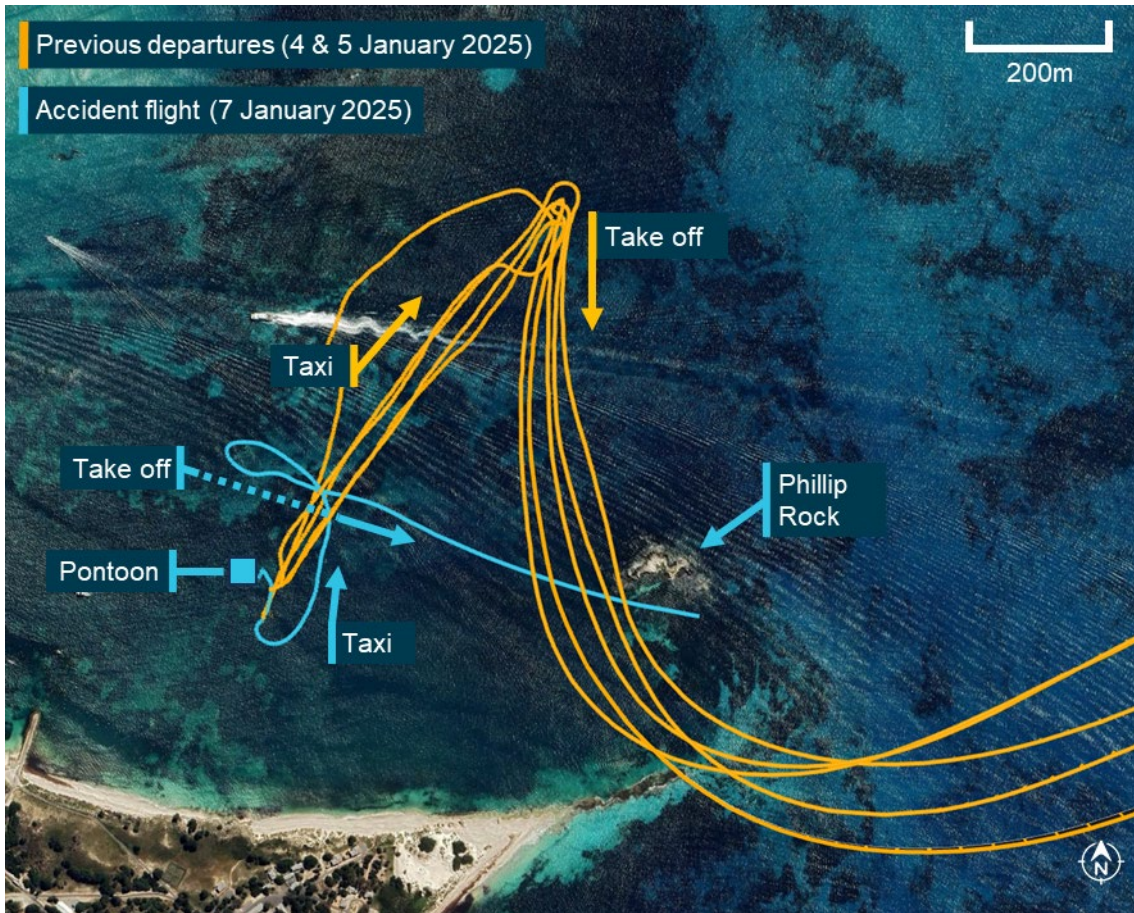
Figure 5: Recorded departure tracks for VH-WTY within Thomson Bay displaying the difference between the accident flight and the previous flights

An initial review of flight data by the ATSB showed results consistent with these recollections. There were 6 flights which departed from Thomson Bay after Swan River Seaplanes commenced operations with VH-WTY on 2 January, comprising 3 flights on 4 January, 2 flights on 5 January, and the accident flight on 7 January. All these flights departed with a southerly track, except for the accident flight which departed with an easterly track (Figure 5).

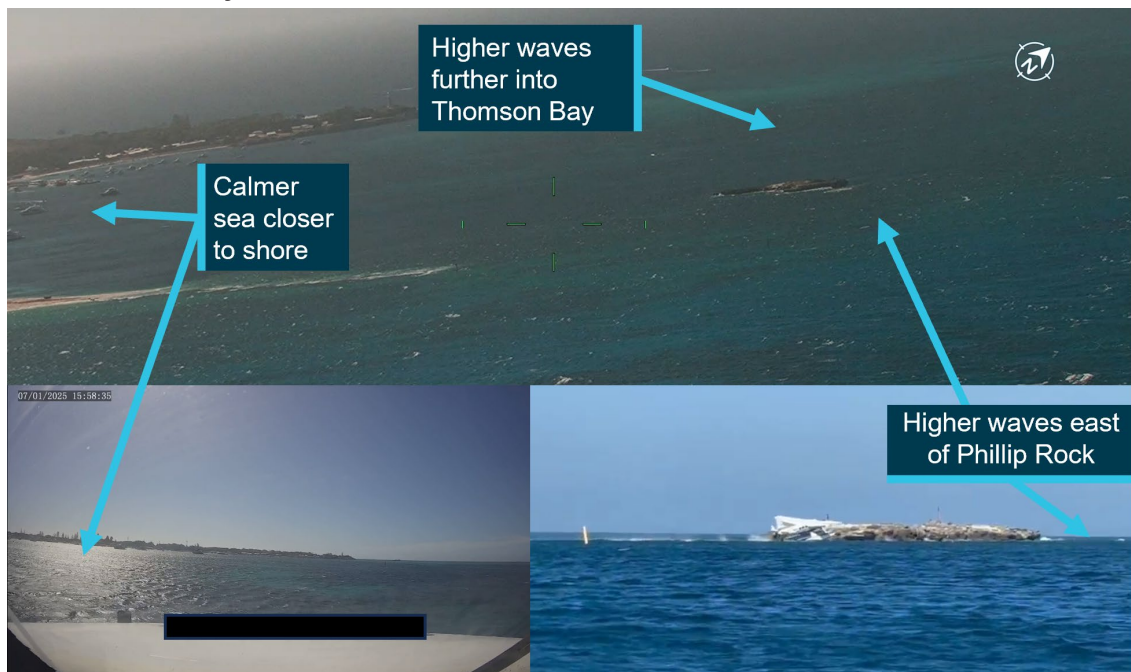
Witnesses to the accident recalled strong gusty winds in Thomson Bay throughout the afternoon of the accident. Video recordings taken on the afternoon of the accident showed that the sea was calm close to the southern shore of Thomson Bay. Further into the bay, however, waves were larger and more frequent. The sea state around the aircraft during the take-off run was choppy, with some white caps. Video showed that beyond the eastern end of Thomson Bay, sea conditions became significantly worse, with larger and more frequent white caps (Figure 6).

Figure 6: Aerial view shortly after the accident near to the impact point showing the rougher sea state outside of Thomson Bay (top), with surface photography from a vessel in Thomson Bay (bottom left) and a witness on the shore (bottom right) showing conditions shortly before the accident.

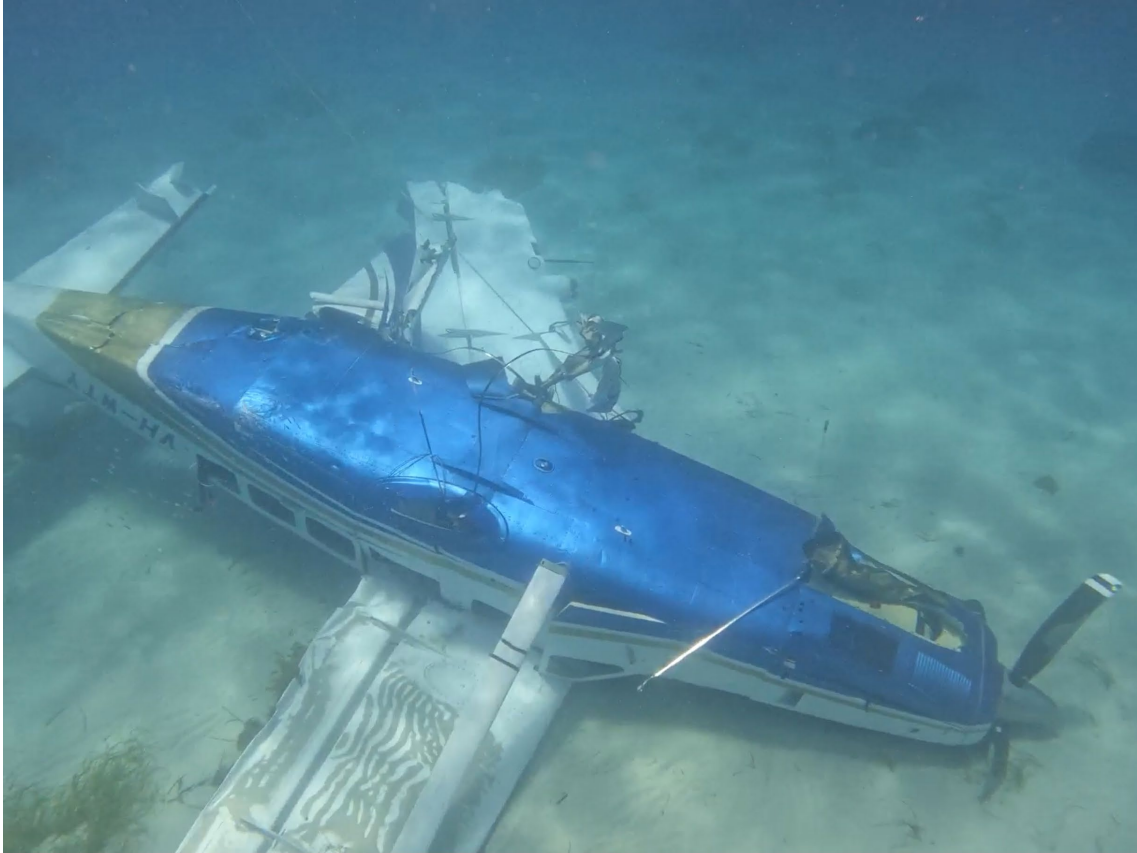
The aircraft drifted approximately 800 m north of Phillip Rock until being tethered to the sea floor by WA Police divers. Their dive video showed that the main body of the aircraft remained largely intact following the collision (Figure 7). On 9 January 2025, commercial salvors lifted and recovered the aircraft using barges and a crane (Figure 8), before it was transported to a secure storage facility near Perth for further examination.

Figure 7: The aircraft sank inverted onto the sea floor within Thomson Bay

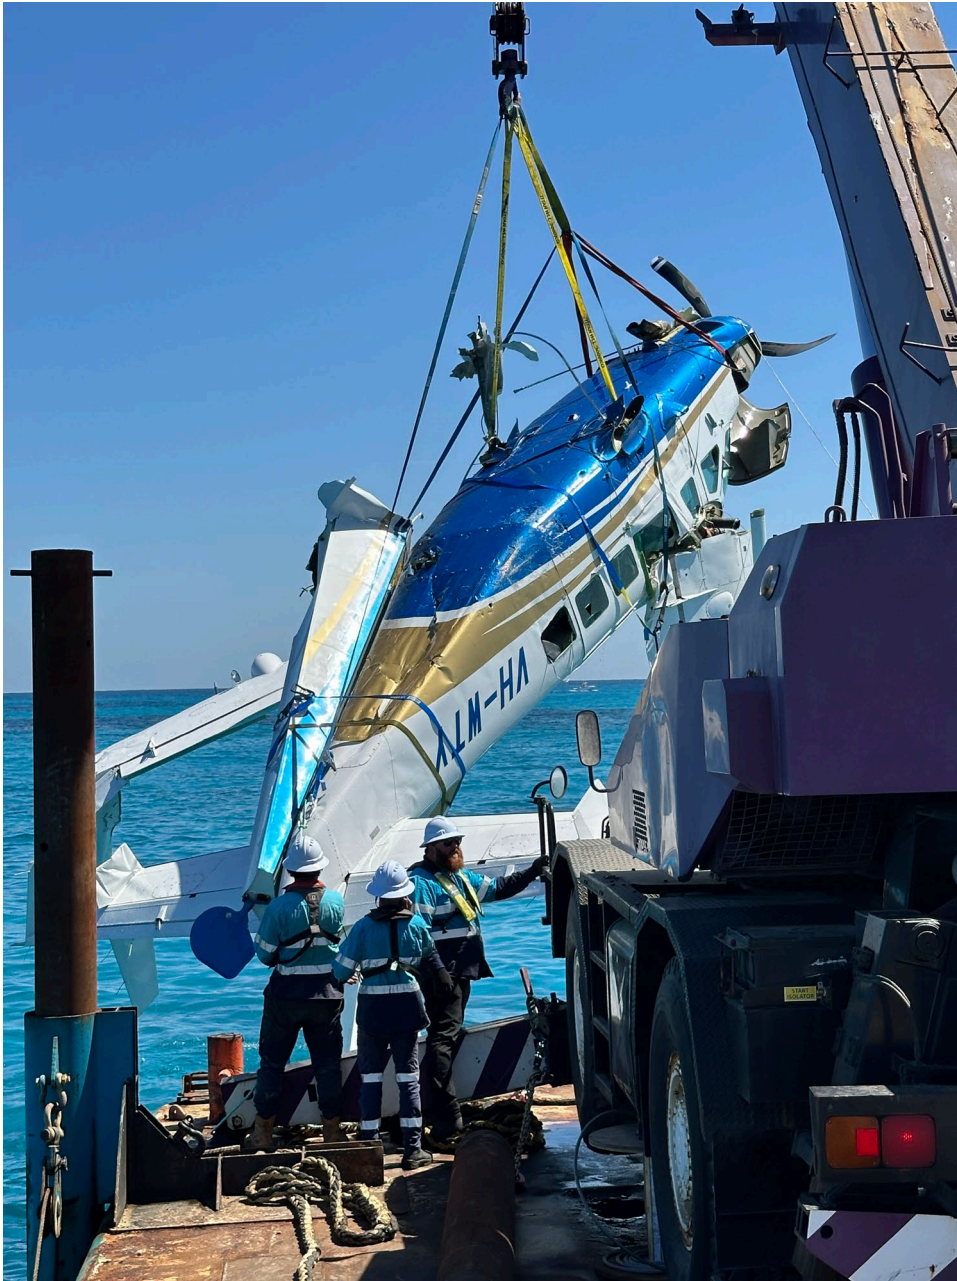
Figure 8: VH-WTY recovery from Thomson Bay

- The wings, fuselage and floats did not display any physical markings that the aircraft had struck landmass or a submerged object prior to the collision with the sea.
- The engine controls were attached to the associated engine components and were free to move through their full range of movement.
- The propeller blades were intact and attached to the propeller hub. They could be rotated through 360° about the feathering axis, indicating internal damage to the feathering mechanism. The investigation will include further analysis to determine the significance of this damage.

- All 3 propeller blades were significantly bent toward the blade face. The significance of this was not able to be determined due to the propeller assembly resting on the sea floor prior to recovery.

- The wings were swept back, with significant damage to both wings outboard of the ailerons. The left wing section, outboard of the aileron pushrods, was separated during the accident sequence and not recovered.

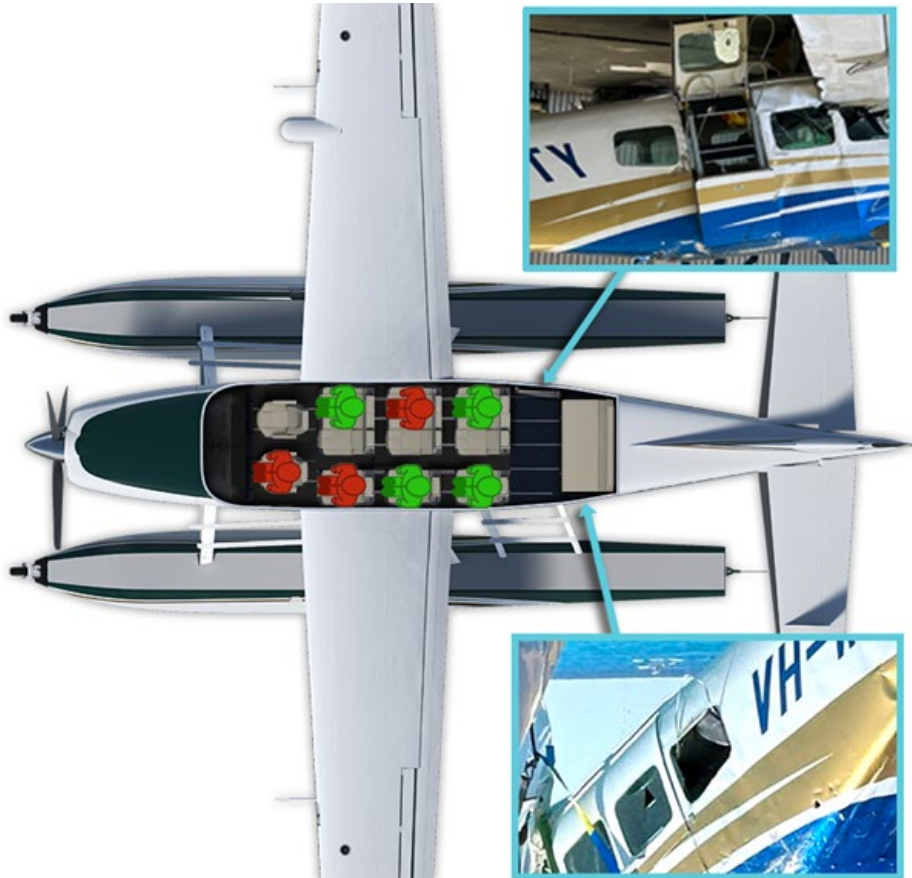
- The pilot was seated in the normal position in the front left seat, and there was no passenger seated in the front right (copilot) seat.
- Two passengers were seated in the second row, with the central seat vacant. The passenger seated in the left seat was fatally injured in the accident. The passenger in the right seat recalled escaping through the rear left window, which had been broken by the coxswain of the operator's tender vessel.

- Two passengers were seated in the third row, with the central seat vacant. The passenger seated in the right seat was fatally injured in the accident. The passenger seated in the left seat was pulled from the aircraft through the left rear window by the coxswain of the operator's tender vessel.
- Two passengers were seated in the fourth row, with the central seat vacant. Both passengers in the fourth row survived the accident. The passenger seated in the left seat of the fourth row opened the top section of the right rear door, through which they exited the aircraft along with the passenger seated in the left seat of the fourth row.

Figure 9: Cessna 208 seating plan showing the occupant location for those who survived (green) and those who sustained fatal injuries (red)

Passengers were able to exit the aircraft using the top section of the right rear door (upper inset) and left rear window (lower inset). Source: Textron Aviation, modified by the ATSB
