# **FINAL REPORT**

**SERIOUS INCIDENT**  
**Aircraft B787-8 registration marks LN-LND,**  
**Rome Fiumicino International Airport, Italy,**  
**10<sup>th</sup> of August 2019**

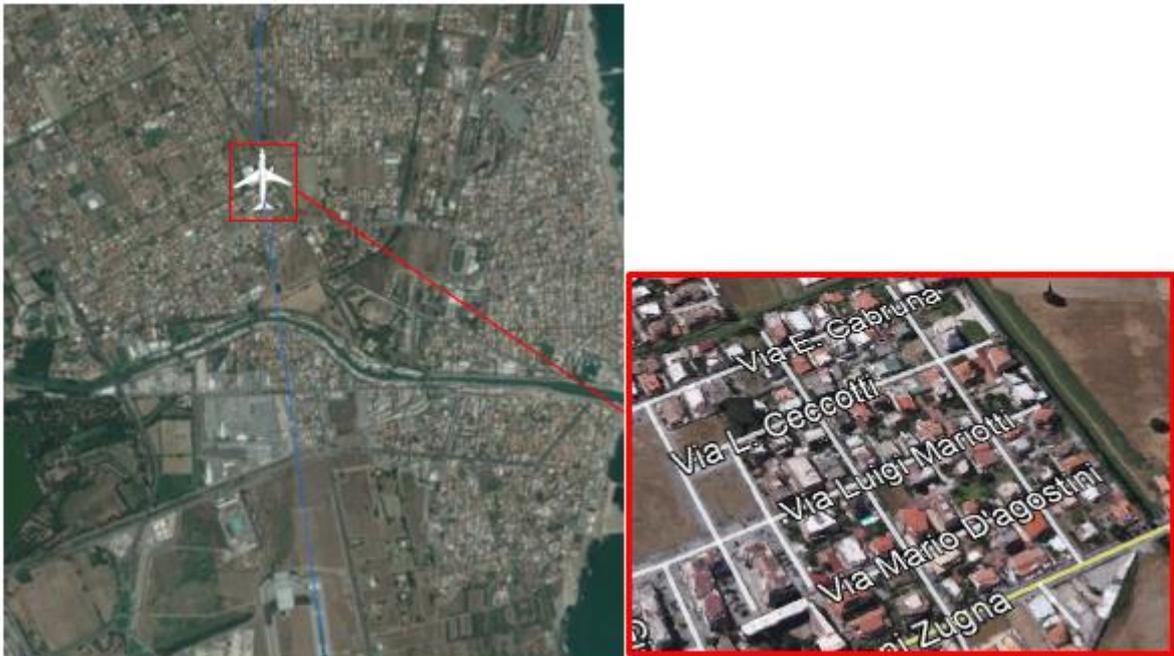
About 4 kg of debris (mainly fragments of turbine blades, photo 11) ejected from the left engine were recovered from the streets of Fiumicino (the city nearby the airport, detail in the red rectangle in figure 2), along the direction of the runway, where several damages to cars (mainly broken windows, photo 12, and indentations on the car body) and buildings (mainly holes in awnings) were reported by the population. No debris were found within the airport area. The larger fragments found weighed of about 100 g. The subsequent analysis of the engine made by the manufacturer suggested that about 38.2 kg was the total weight of the parts ejected from the engine.

Figure 2: position of the aircraft at the time of activation of the discrete FDR parameter “Eng1 Vib Warn”; detail of the streets where most of the turbine blade fragments were found.

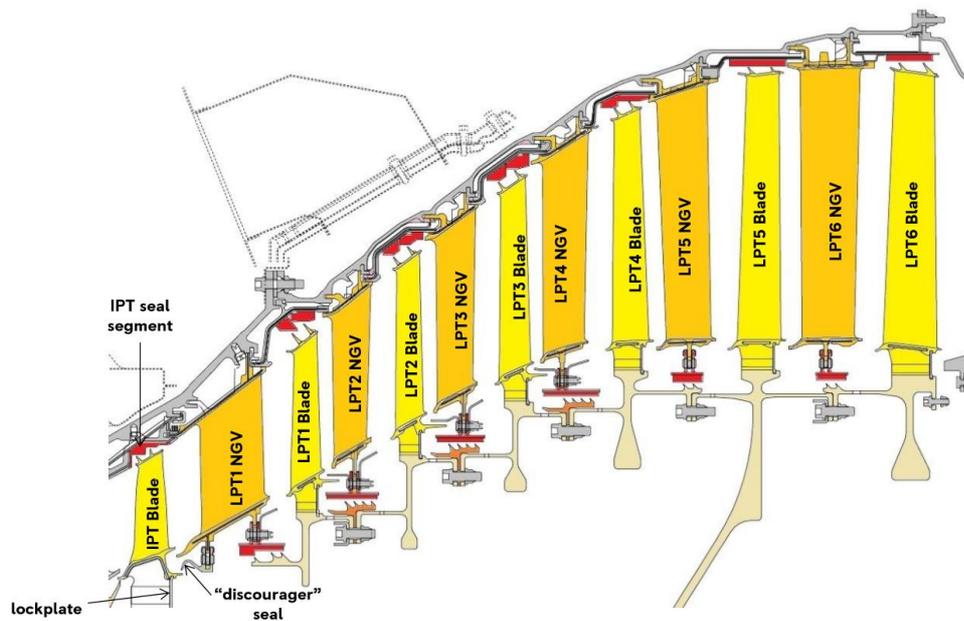
Figure 28: detailed diagram of IPT and LPT stages.

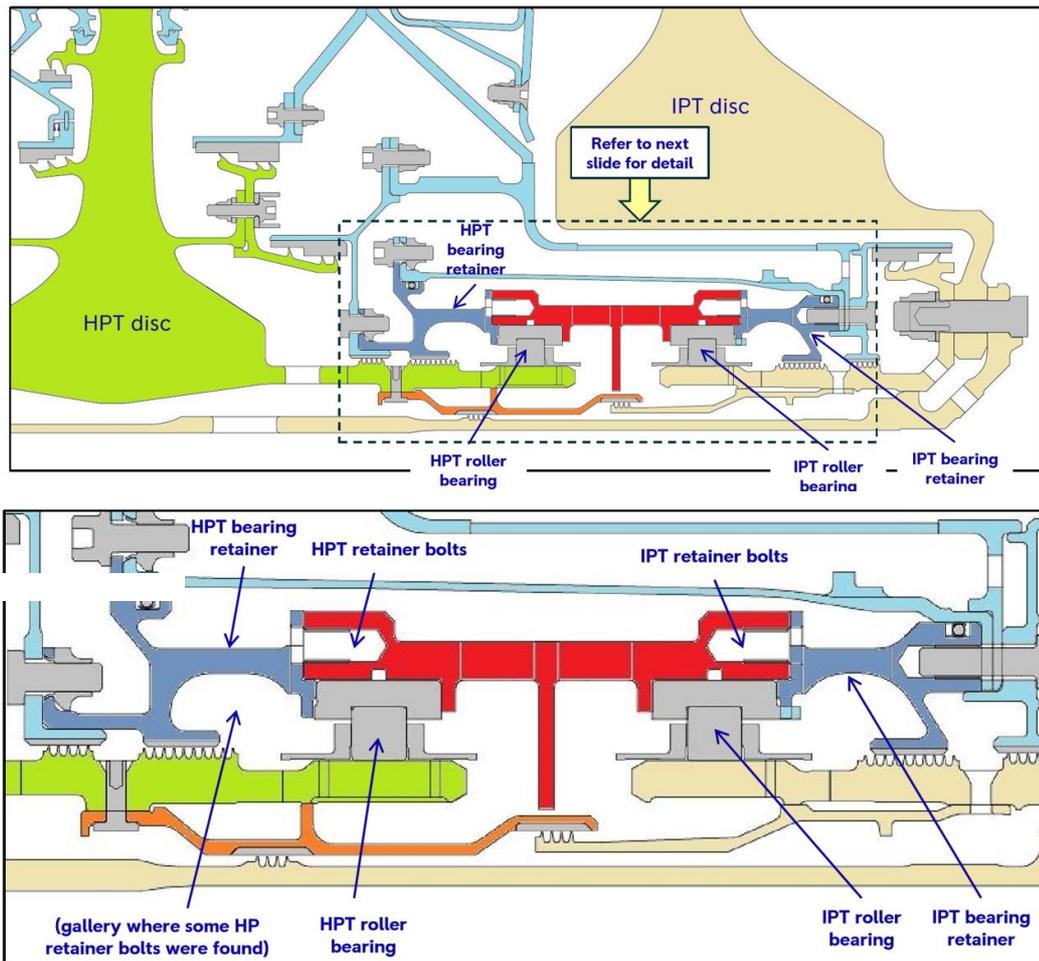
Damages to the HP/IP bearings (figure 31) were also found.

Figure 31: HP/IP bearing housing diagram.

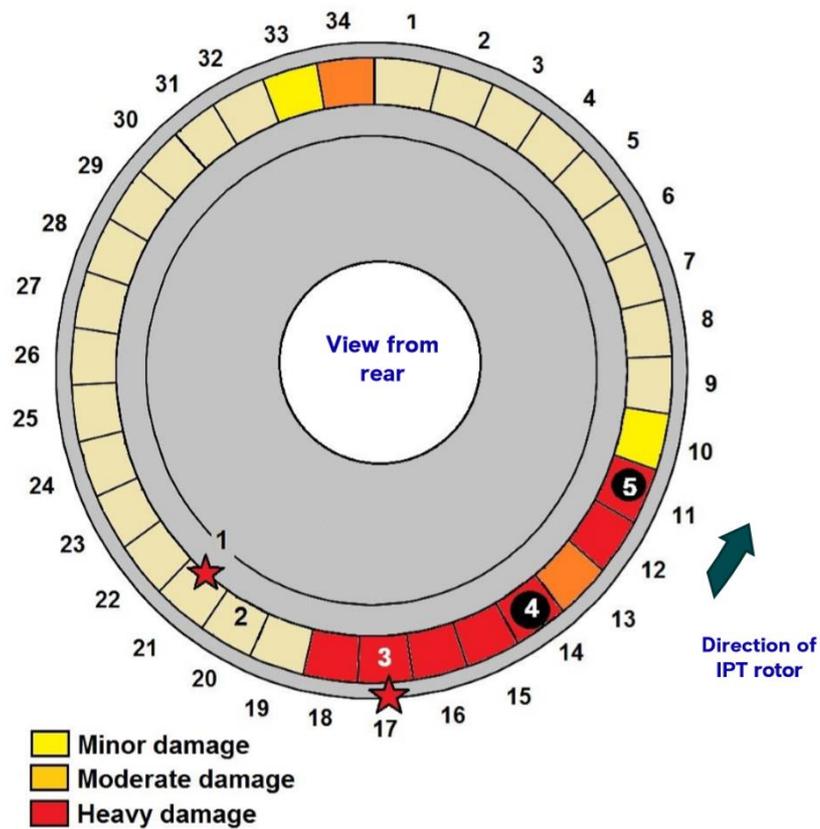
Figure 32: scheme of the LPT1 NGV.

Regarding the LPT1 NGV stage, it is made up of 34 sectors each one 3-off vanes per pack, for a total of 102 vanes. The greatest damage was found to the leading edges through an arc of  $\sim 80^\circ$  between sector 11 and 18 (figure 32 and photo 23, the trajectories of the fragments that caused the damage are also illustrated). All the rest are also damaged to a lesser degree.

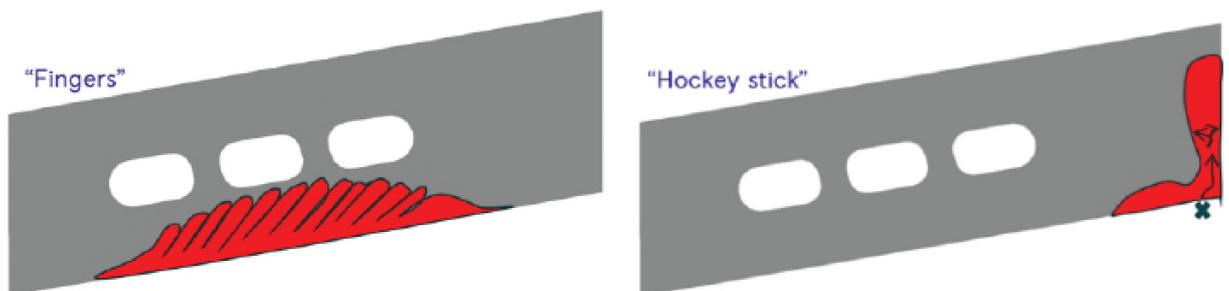
- the progression of the crack was via tunneling crack (approximately 200  $\mu\text{m}$ ). It grew towards the leading and trailing edges subsurface and branched toward the convex face and core;
- a “hockey stick” feature was present across the full width of the rear face (photo 34 and explanatory diagram of the characteristic in figure 33);
- from the tunneling the crack propagated along “fingers” through the thickness of the root downstream of the convex edge (photo 35, explanatory diagram of the characteristic in figure 33).

Figure 33: fingers and hockey stick.

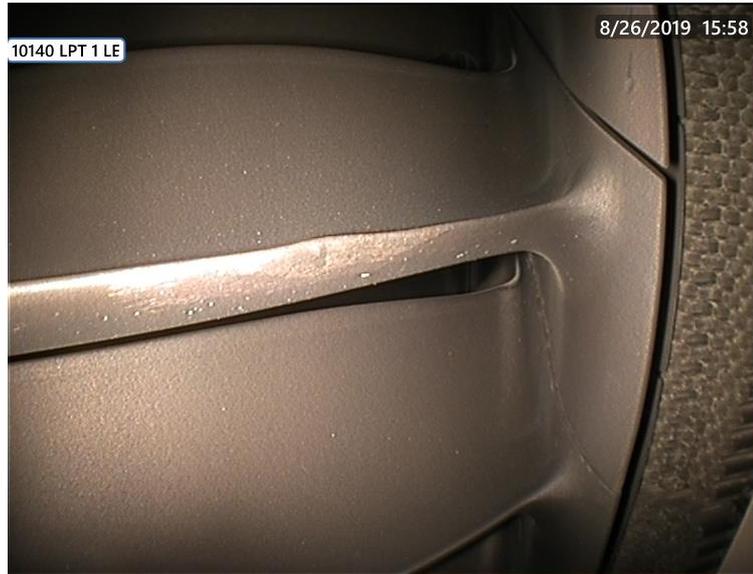
Photo 40: rework on LPT blades.
