Collision with water involving Cessna 208 Caravan, VH-WTY

Thomson Bay, Rottnest Island, Western Australia, on 7 January 2025

ATSB Transport Safety Report
Aviation Occurrence Investigation
AO-2025-001
Preliminary – 27 February 2025

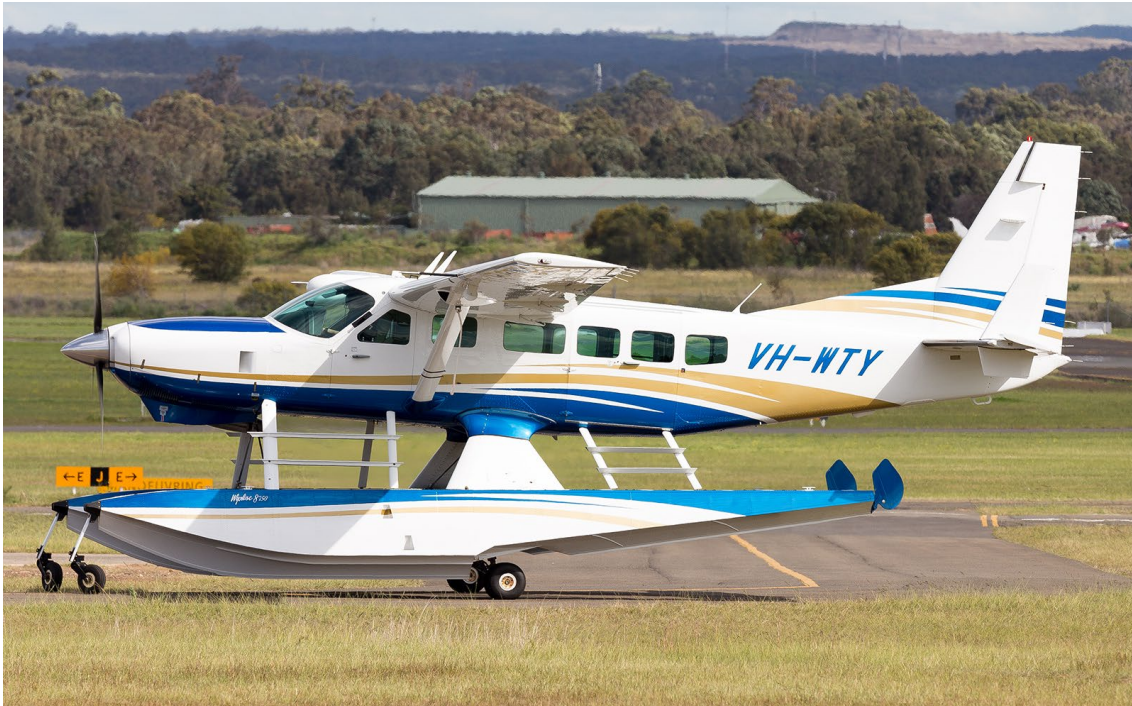
Figure 3: VH-WTY

VH-WTY (Figure 3) was a Cessna 208 Caravan Amphibian² floatplane, powered by a single Pratt & Whitney Canada (P&WC) PT6A-114A turboprop engine and a 3-bladed McCauley constant speed propeller. The aircraft was fitted with Wipline Model 8750 amphibious floats which enabled operation from both land and water. It was configured in a 13-seat interior layout. The aircraft was manufactured in the United States in June 2016, then registered in Australia in September 2016. It had accumulated about 1,125 hours total time in service at the time of the accident. Further aircraft information is detailed in *VH-WTY maintenance history* below.

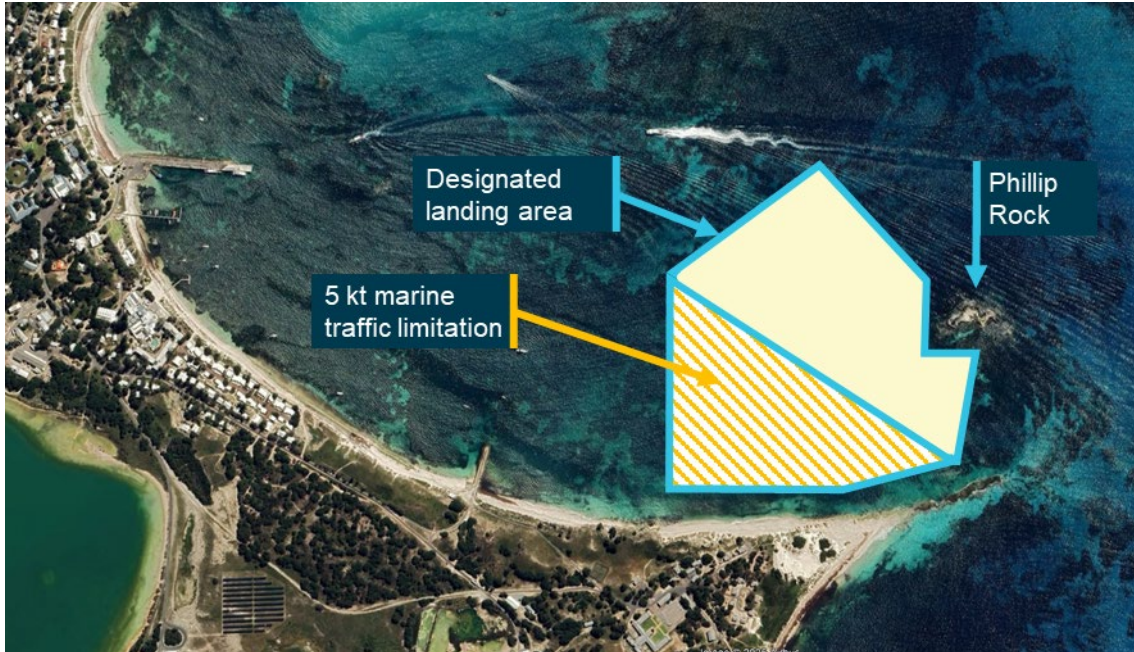
Figure 4: Thomson Bay approved floatplane landing area

The operator had received approval to conduct water landings and departures into and out of Thomson Bay. Swan River Seaplanes pilots reported that flights to Rottnest Island would normally utilise the sealed runway at the airport, and that Thomson Bay would only be utilised if forecast weather (wind direction and wind speed) would make the sealed runway unsuitable. The approval included a designated landing area, located in the south-eastern end of Thomson Bay, with the south-western area of the landing area subject to a 5 kt marine traffic limitation (Figure 4). Company pilots reported that it was normal practice to depart from Thomson Bay along a southerly track and to become airborne prior to the 5 kt limitation.
